Development of Best Practices for Inspection of PT Bridges in Minnesota

Minnesota
Department of
Transportation

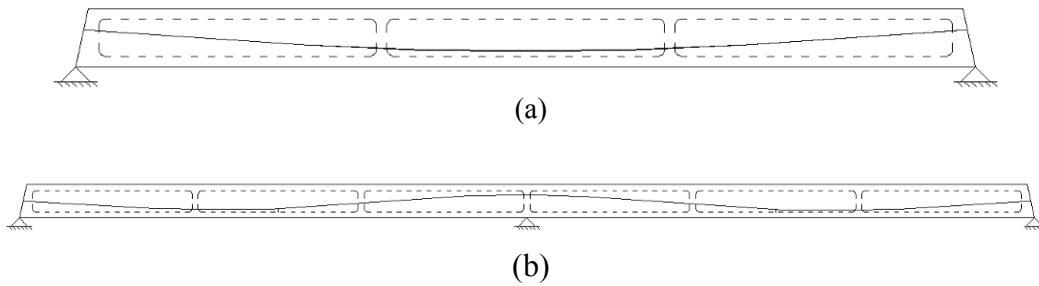
Figure 1.2. Representations of typical tendon profile for single (a) and multi-span beams (b) (not to scale)

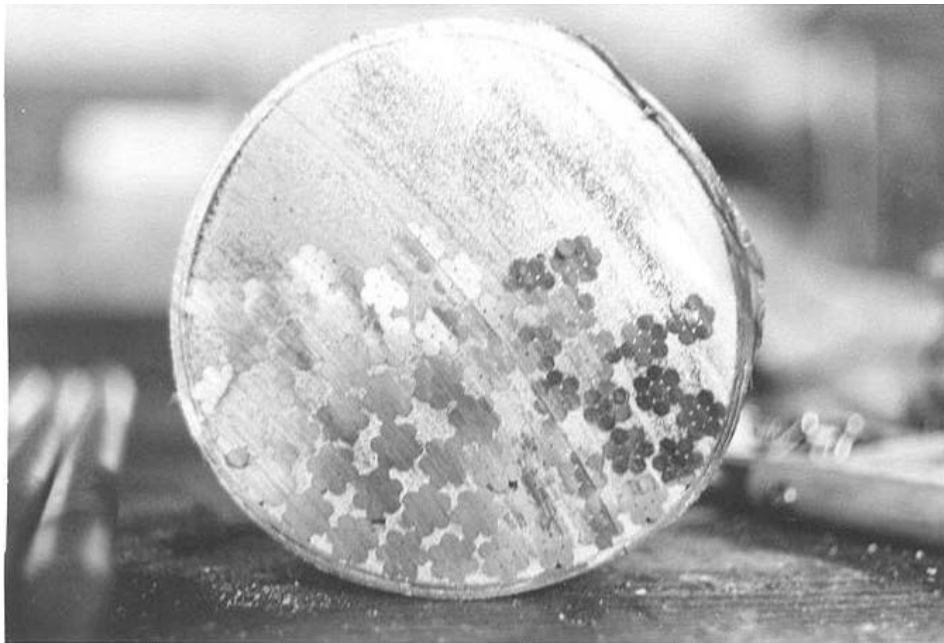
Figure 1.3. Post tensioned duct (cross section) filled with grout (Schokker and Schupack, 2003)

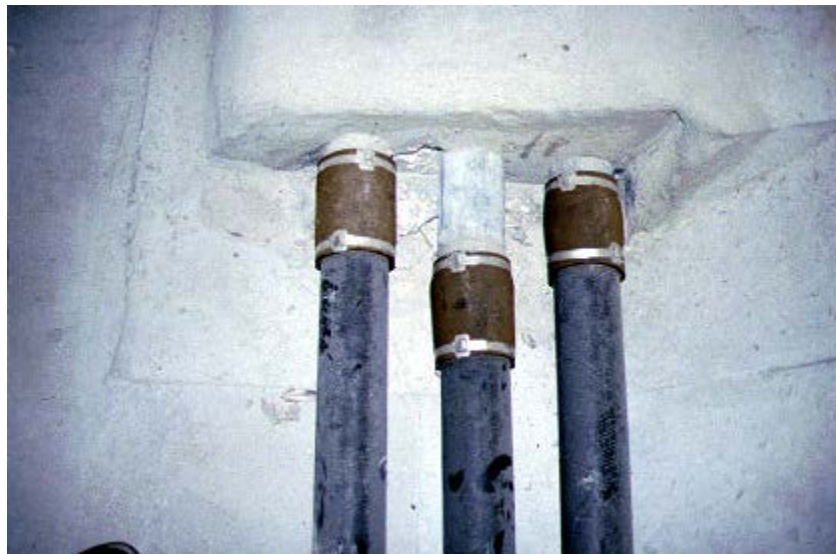
Figure 2.1. Plan view of tendon slip at deviation saddle (Corven Engineering, 2002)

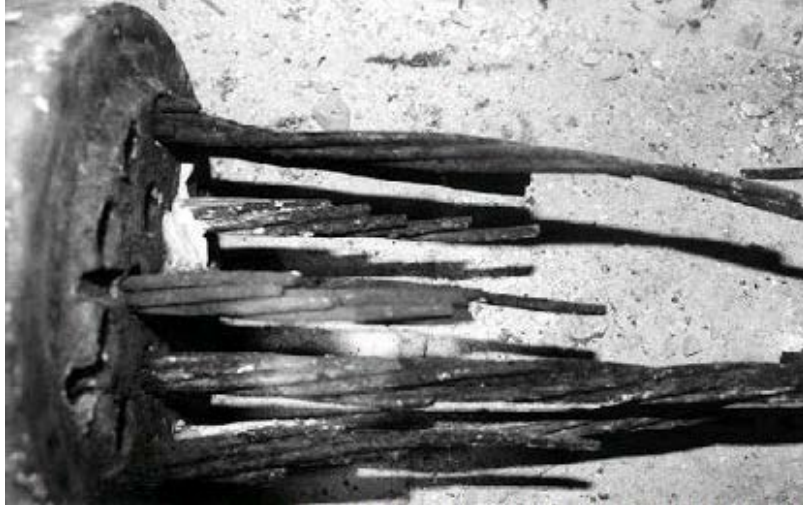
Figure 2.2. Strands corroded at anchor (Corven Engineering, 2002)

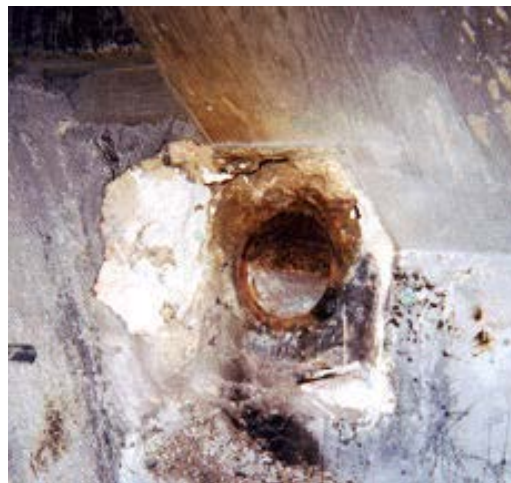
Figure 2.3. Water staining at expansion joint around anchor where tendon corroded (Corven Engineering, 2002)

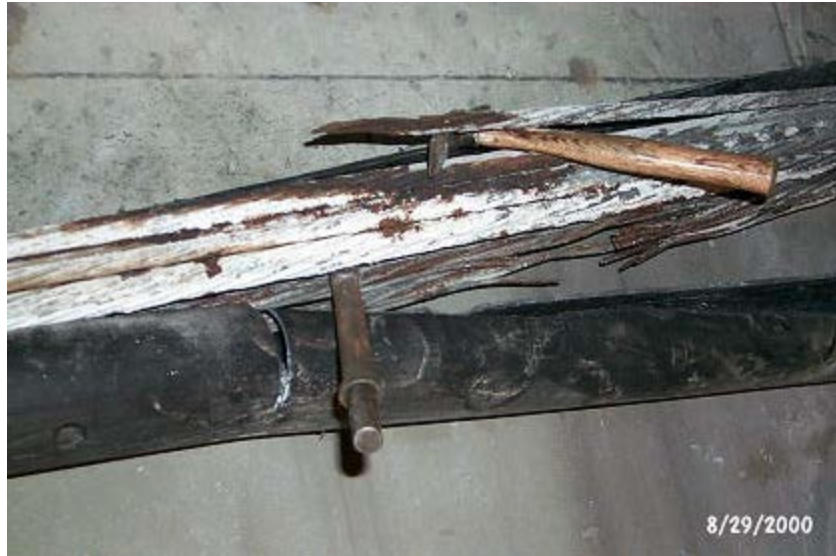
Figure 2.5. Corroded tendons at breached duct (Corven Engineering, 2002)

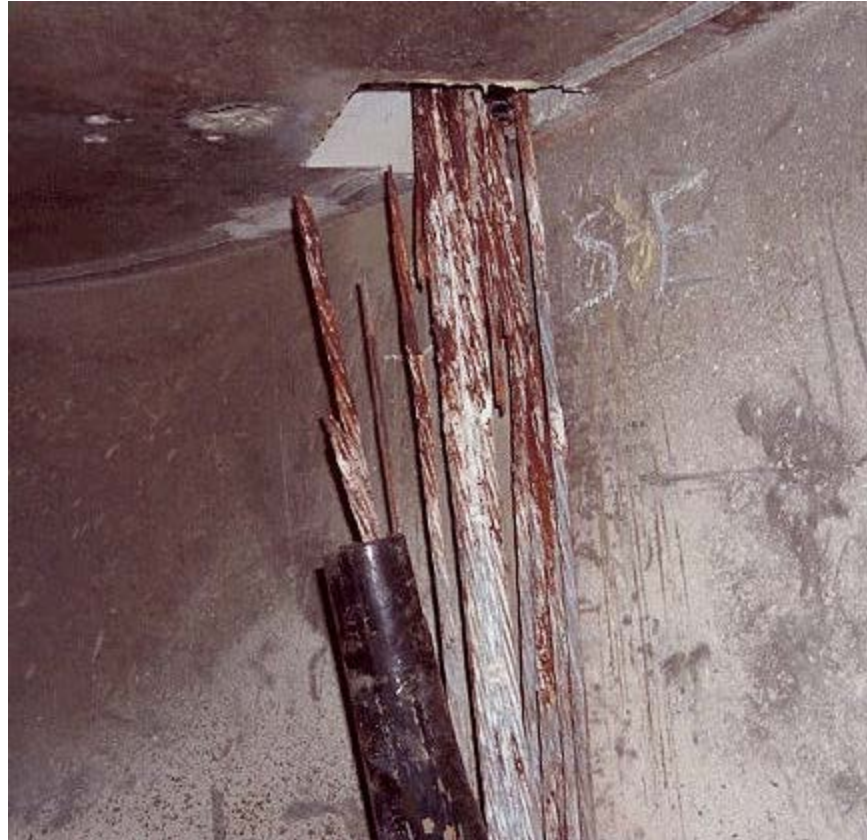
Figure 2.6. Corroded vertical tendons in Sunshine Skyway Bridge piers (Corven Engineering, 2002)

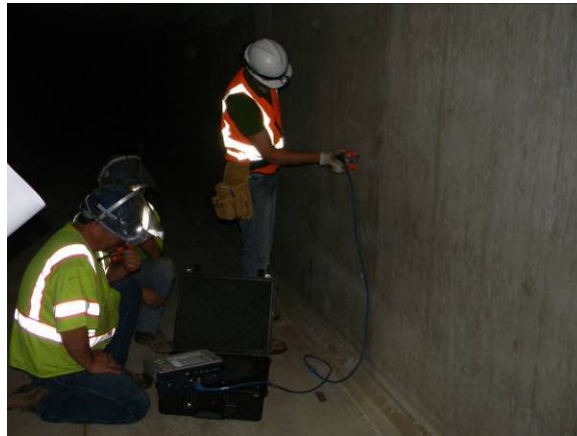
Figure 3.1. Ground penetrating radar in box girder

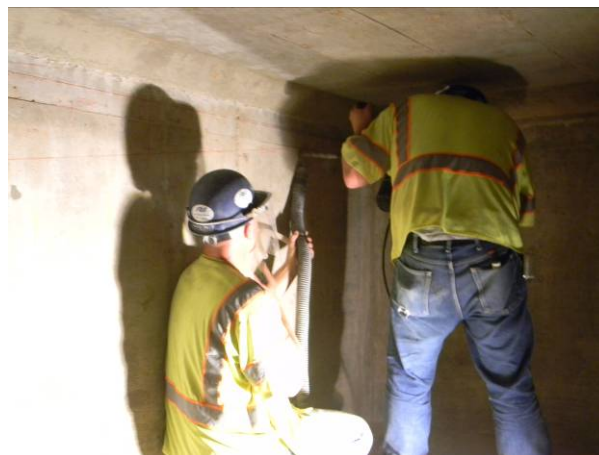
Figure 3.2. Drilling into post-tensioning duct

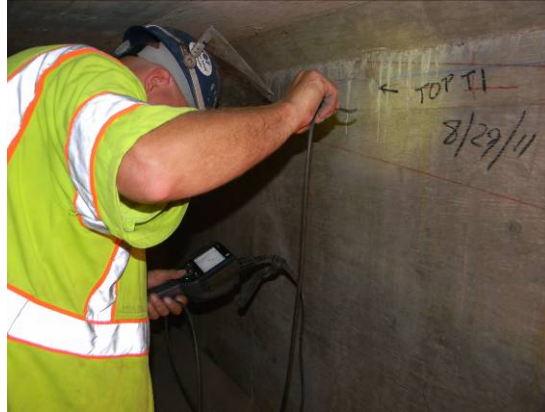
Figure 3.3. Use of borescope into post-tensioning duct

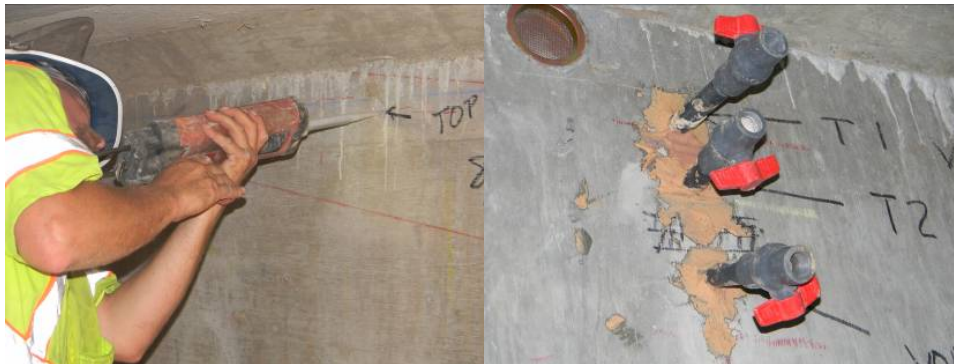
Figure 3.4. (Left) Re-sealed exposed duct holes

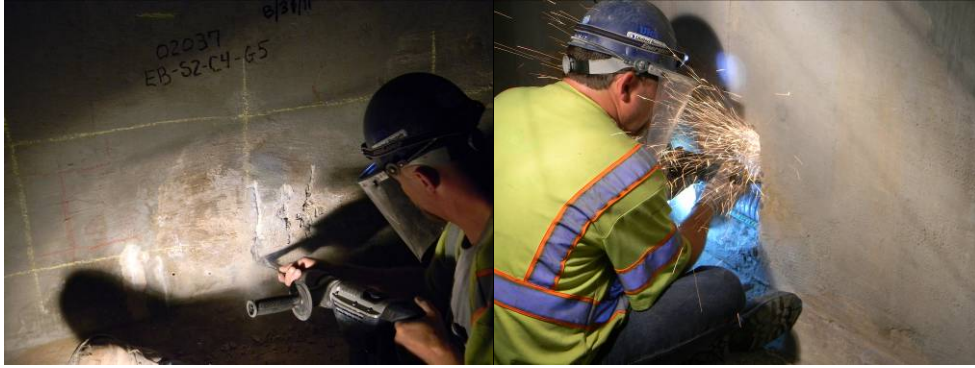
Figure 3.6. (Left) Exposing post-tensioning duct by cutting web

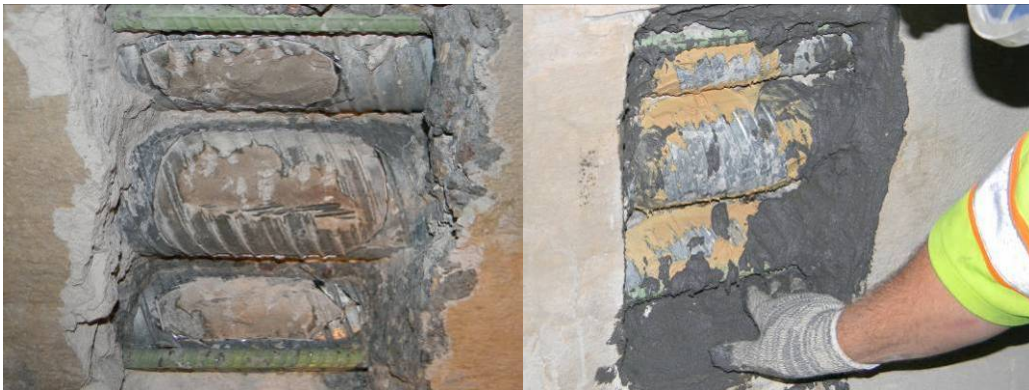
Figure 3.8. (Left) Exposed post-tensioning strand

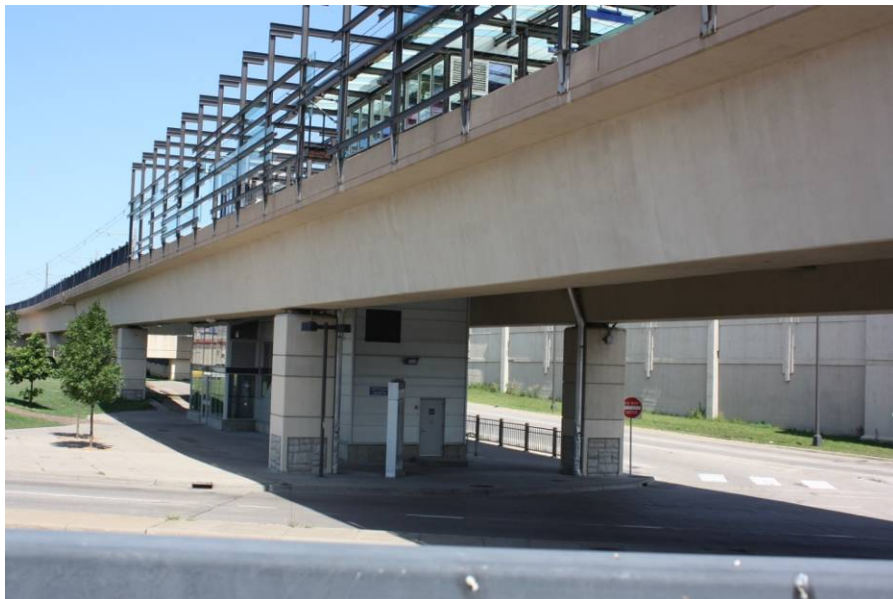
Figure 5.1. Overview of bridge 27262

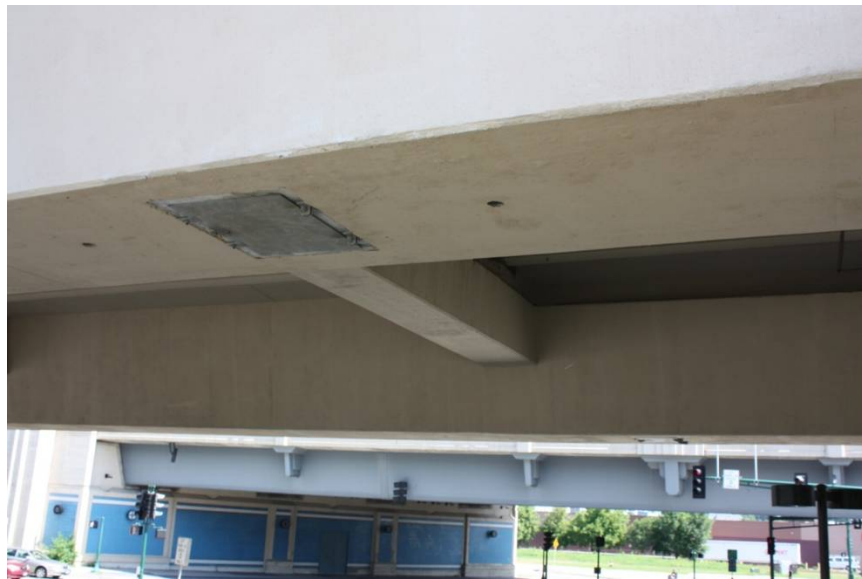
Figure 5.2. Access hatch of bridge 27262

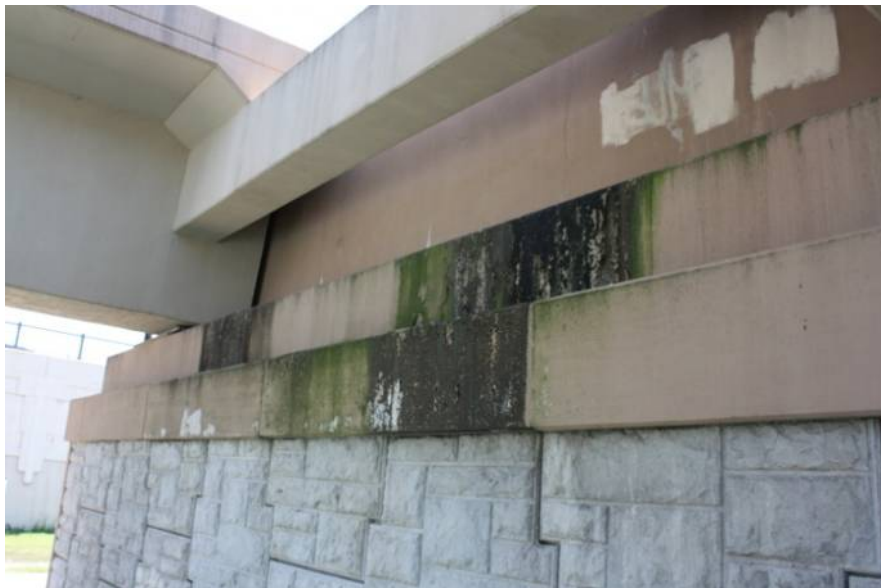
Figure 5.3. Discoloration of abutment

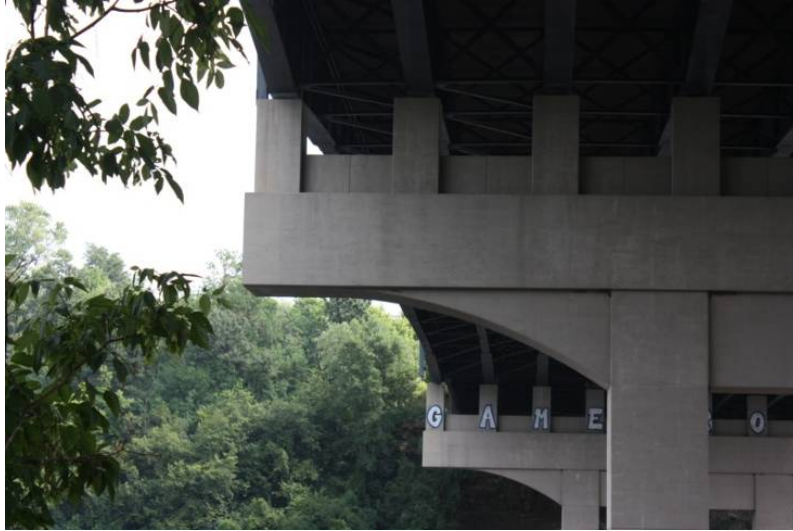
Figure 5.5. Main spans across the Mississippi River

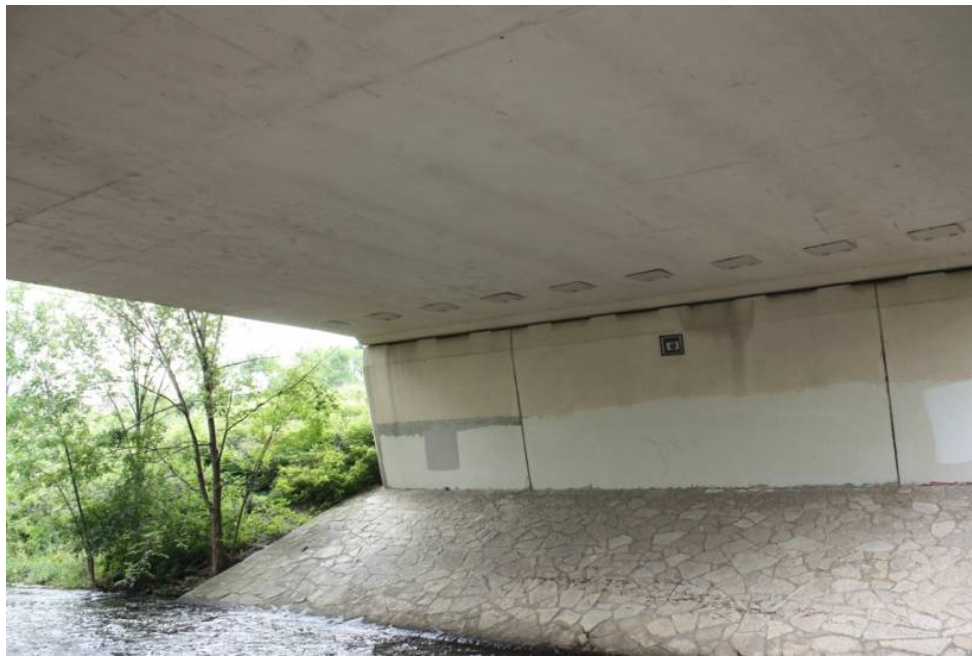
Figure 5.7. Bridge 27719 overview picture

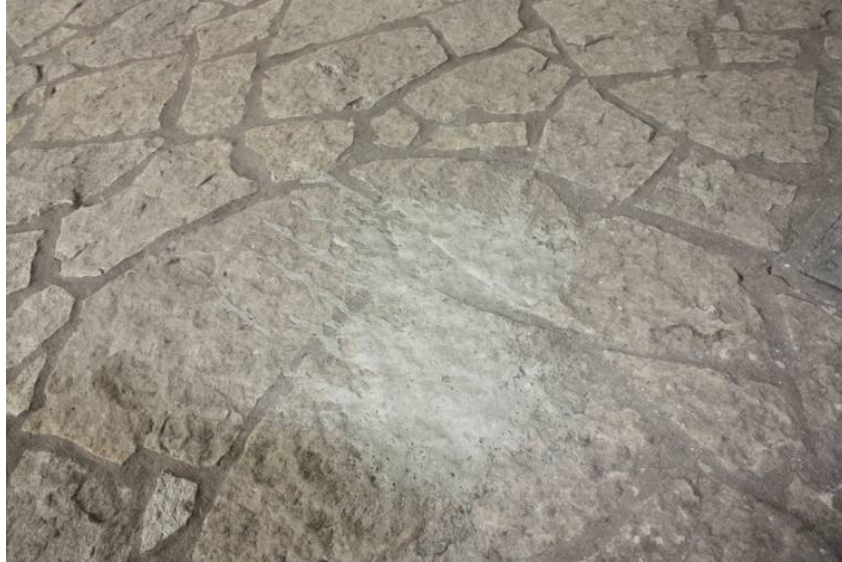
Figure 5.8. Grout splatter beneath access hatch

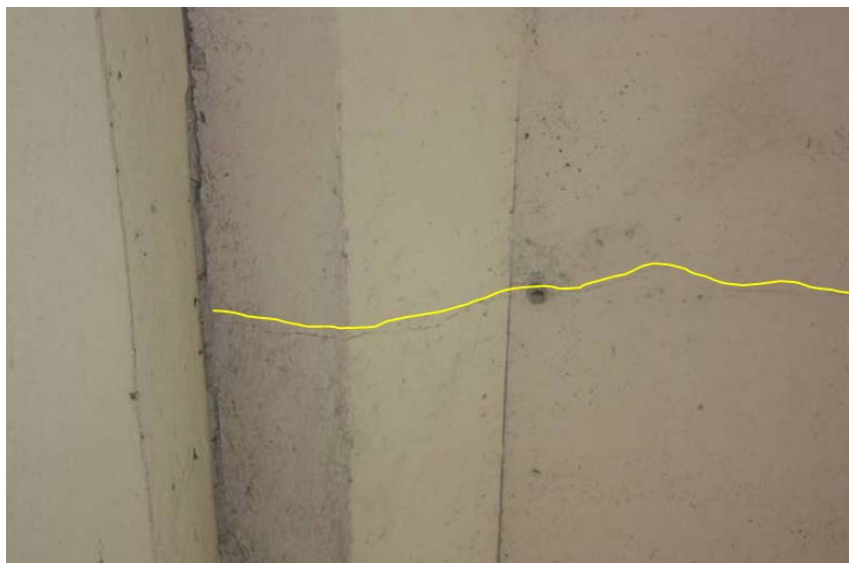
Figure 5.9. Cracking along box girder

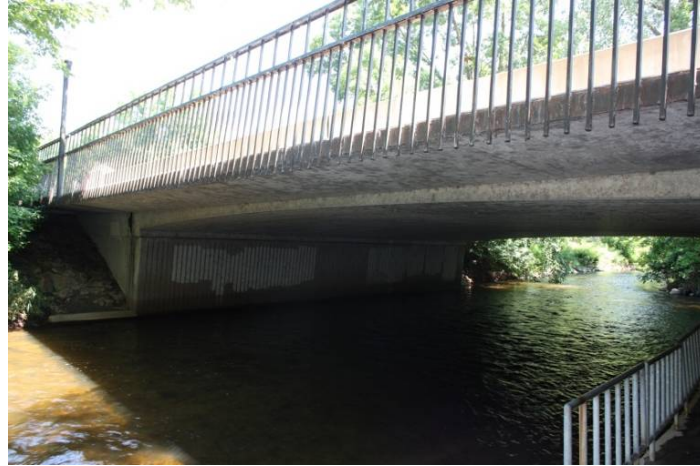
Figure 5.12. Bridge 27547 spanning across the Minnehaha Creek

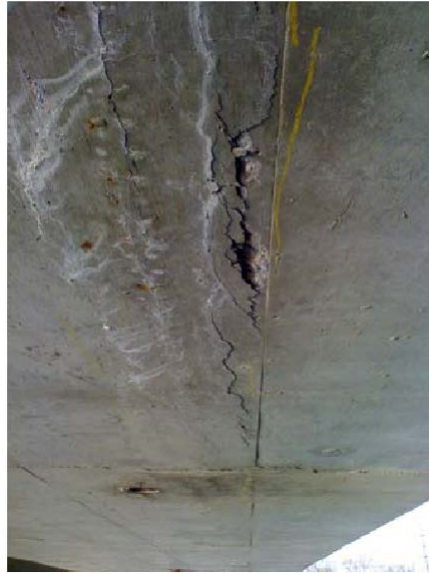
Figure 6.2. Bottom slab damage east to west view (Corven Engineering, 2010)

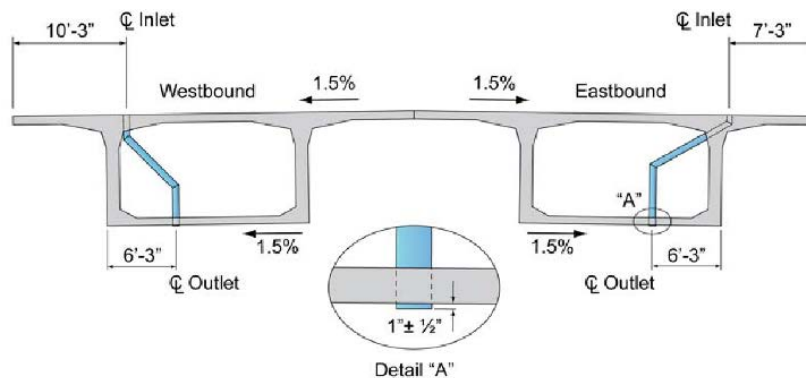
Figure 6.3. Drainage system representation (Corven Engineering, 2010)

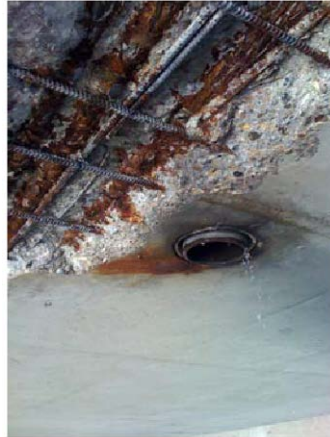
Figure 6.4. Bottom slab drainage outlet (Corven Engineering, 2010)

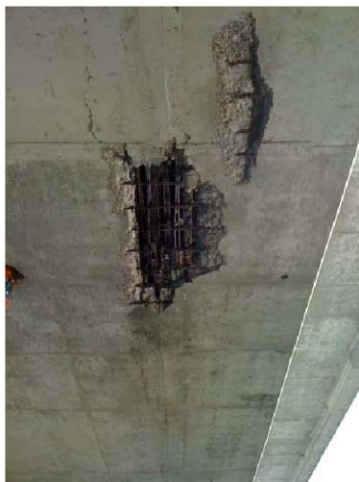
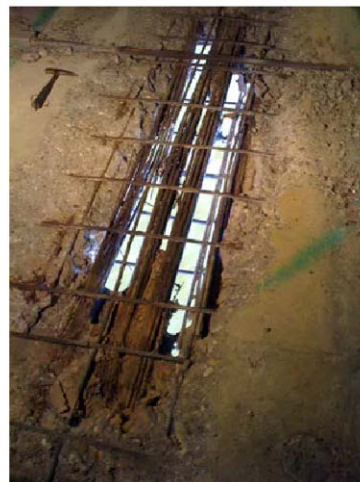
Figure 6.5. (Left) Exposed post-tensioned tendons view exterior (Corven Engineering, 2010)

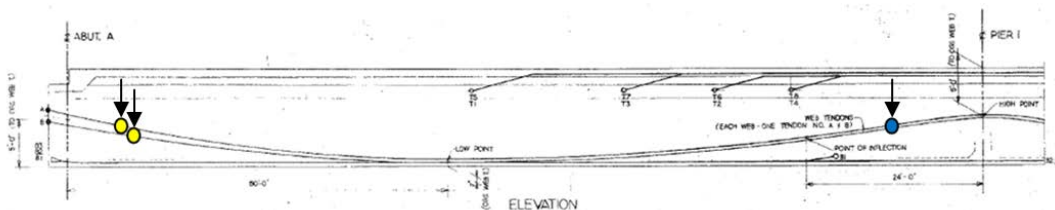
Figure 6.8. Span 1 web S2 and web N2 elevation view

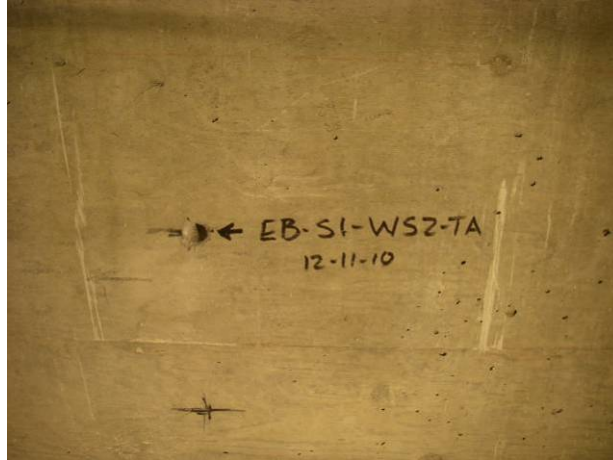
Figure 6.9. Overview photo of drilled hole into span 1 web S2 tendon A

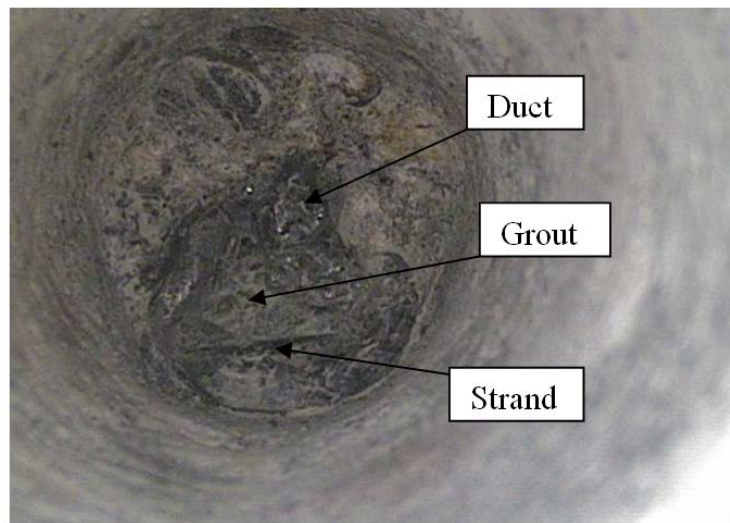
Figure 6.10. Borescope picture of drilled hole in web S2 of span 1

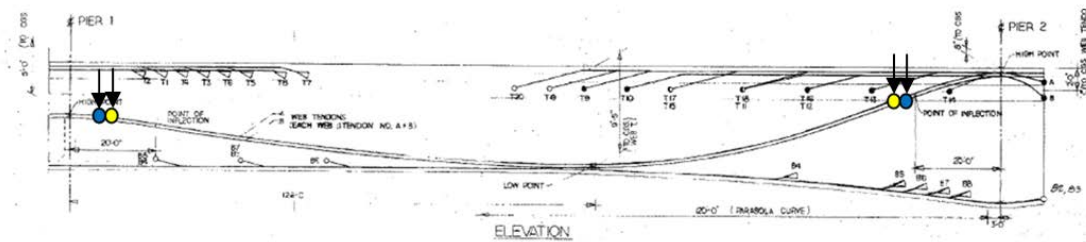
Figure 6.12. Span 2 web S1 and web N1 elevation view

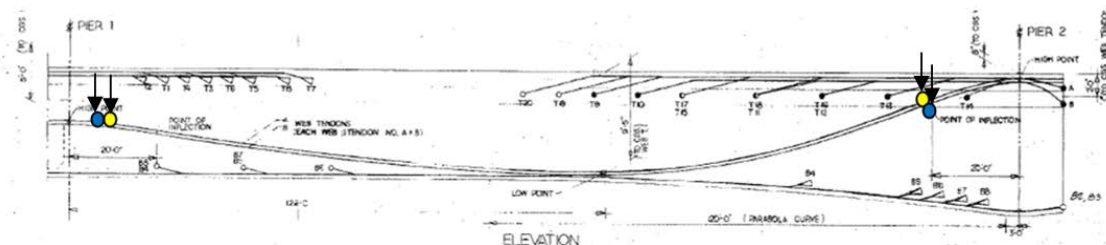
Figure 6.13. Span 2 web S2 elevation view

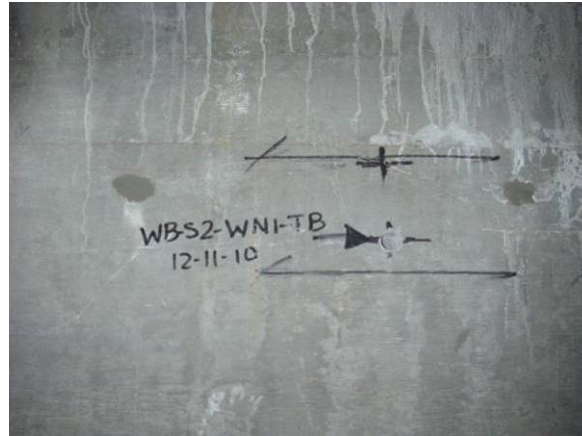
Figure 6.14. Overview photo of drilled hole into span 2 web S2 tendon B

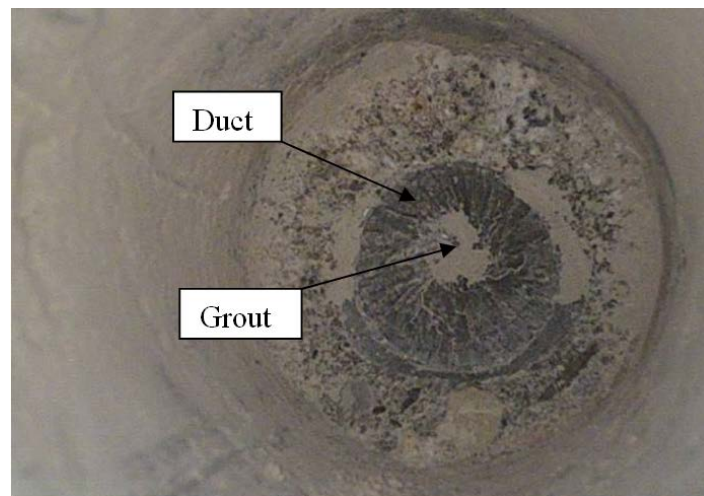
Figure 6.15. Borescope picture of drilled hole in web S2 of span 2

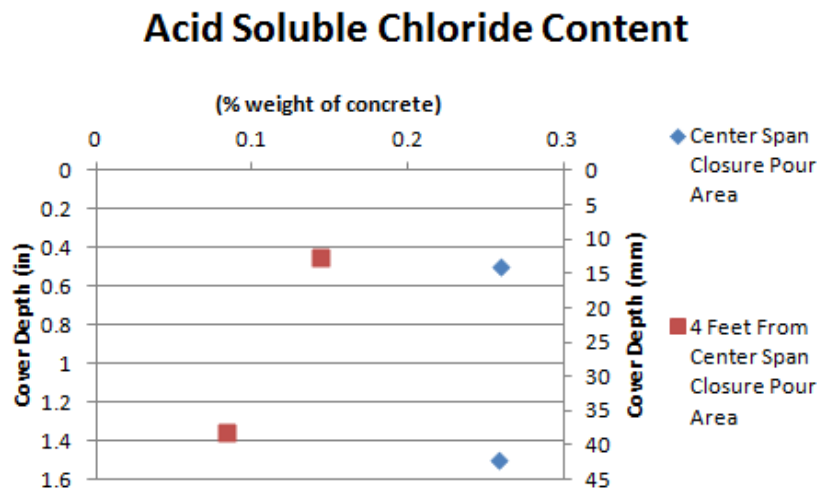
Figure 6.17. Acid soluble chloride content eastbound span 3

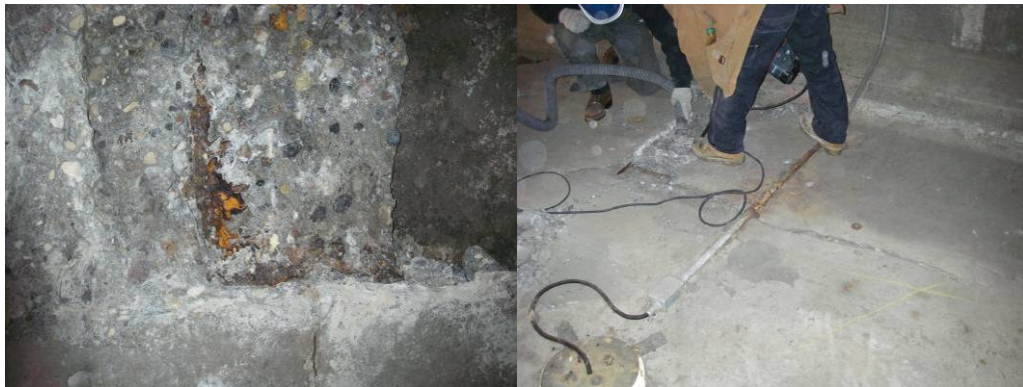
Figure 6.19. (Left) Corrosion product under spalling area at mid span

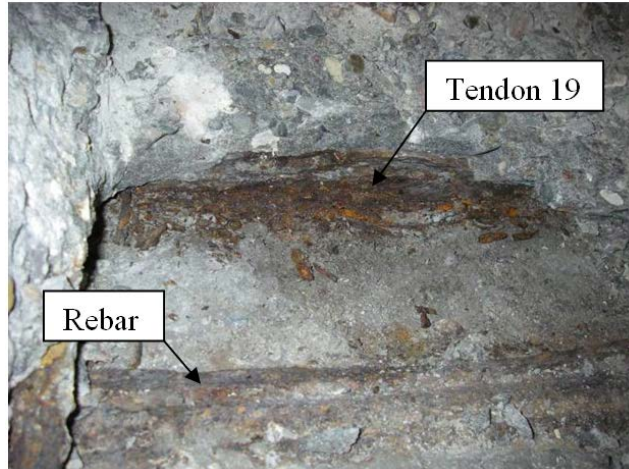
Figure 6.21. Corroded rebar and tendon 19

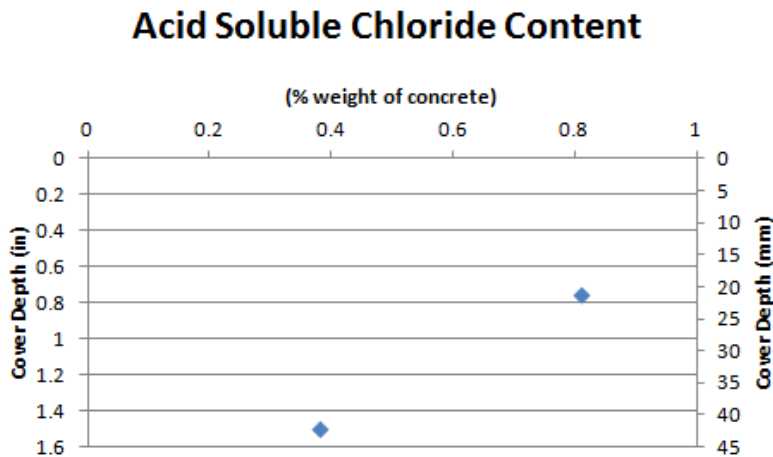
Figure 6.22. Acid soluble chloride results westbound span 3

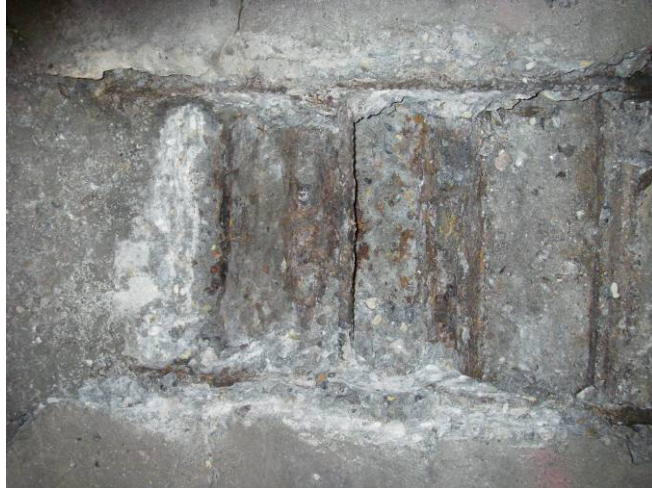
Figure 6.23. Overall view of opened/chipped area at mid span

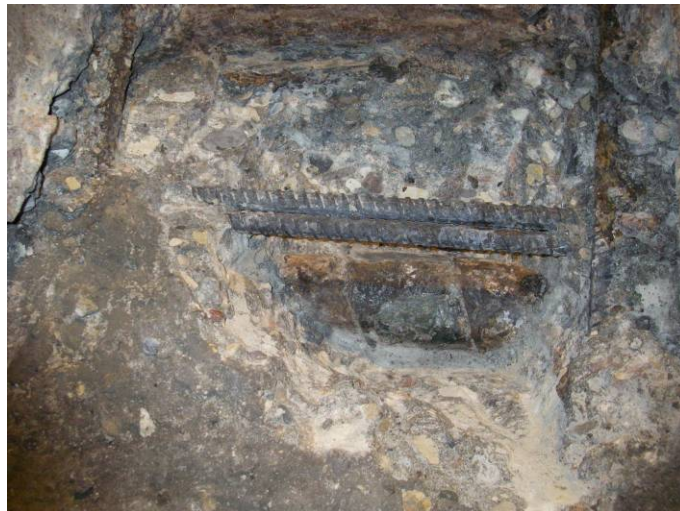
Figure 6.24. Shows tendon 16 with corroded duct

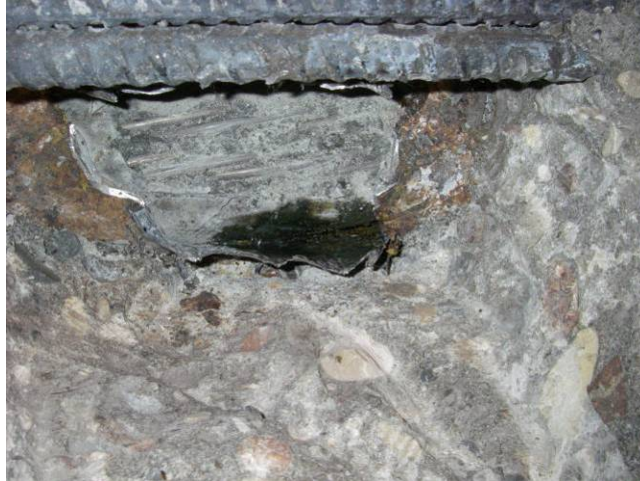
Figure 6.25. Opened tendon 16 with green corrosion product

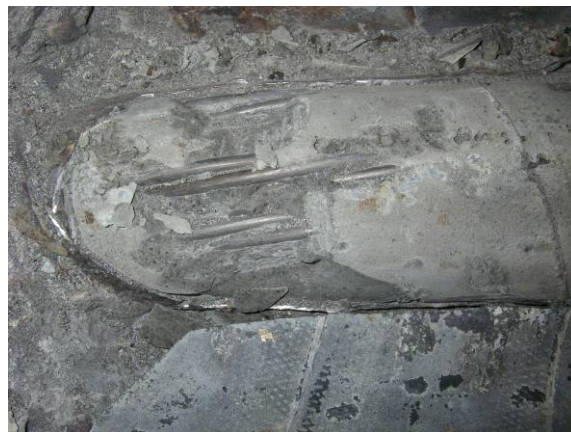
Figure 6.26. Tendon B15 with removed window exposing multiple strands

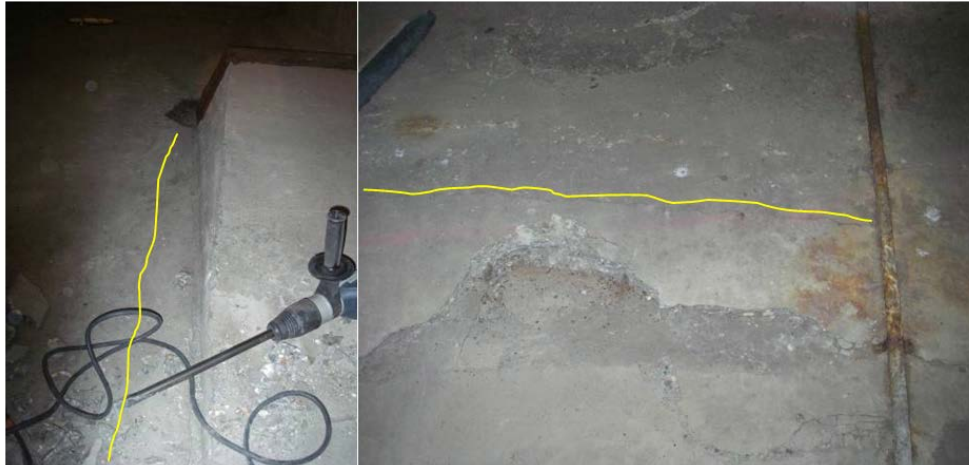
Figure 6.27. (Left) Crack along anchorage of tendon B28/B24

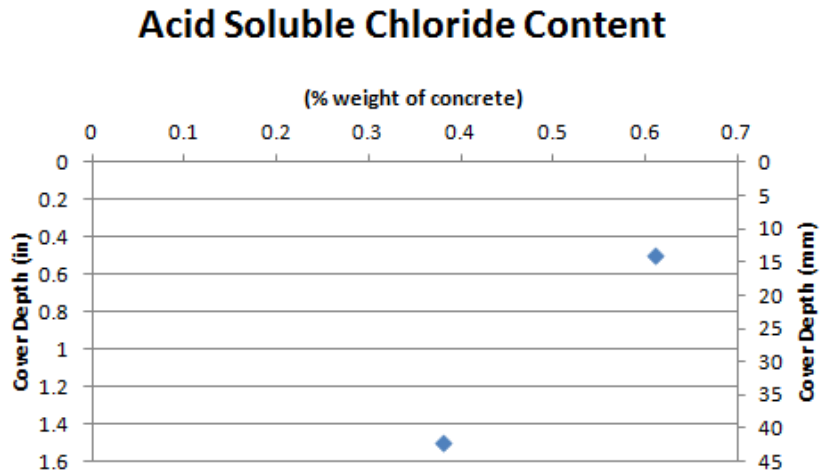
Figure 6.30. Acid soluble chloride test results eastbound span 4

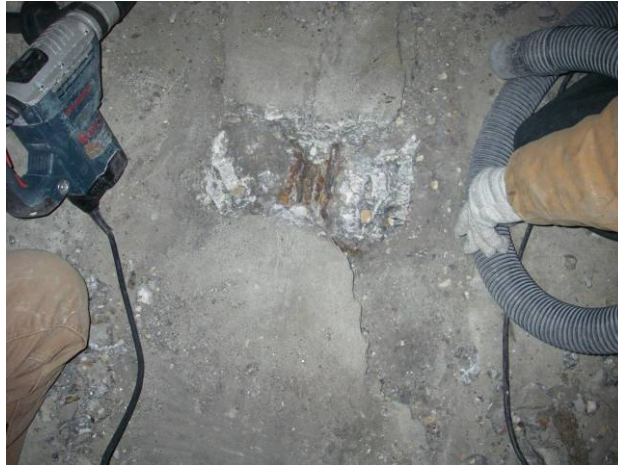
Figure 6.31. Removal of concrete exposing tendon B28

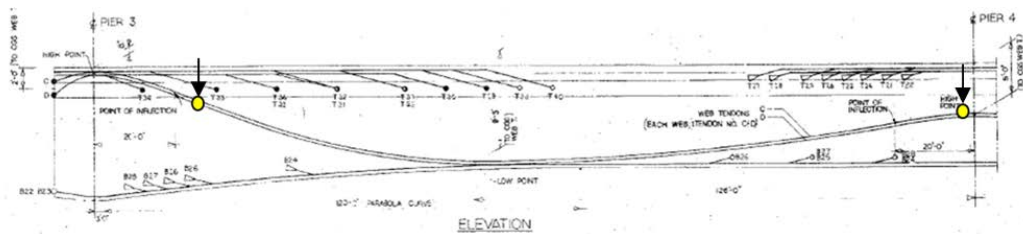
Figure 6.33. Web S1 eastbound structure span 4 drill locations

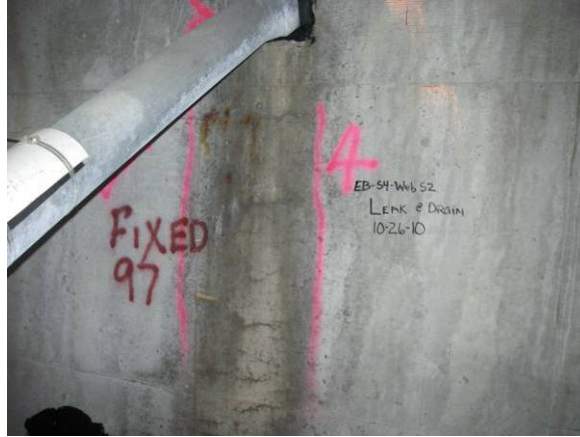
Figure 6.34. Drainage duct with moisture staining

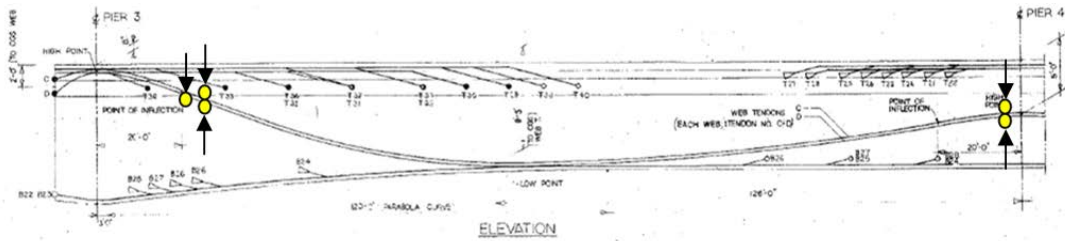
Figure 6.35. Web S2 eastbound structure span 4 drill locations

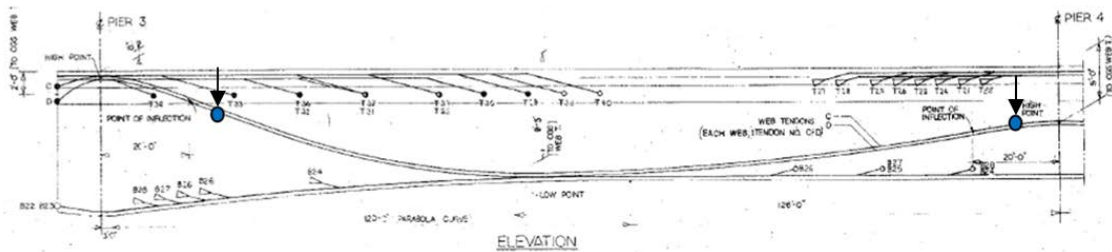
Figure 6.37. Web N1 westbound structure span 4 drill locations

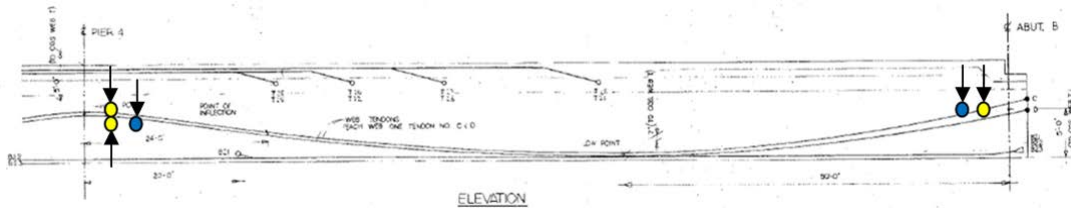
Figure 6.40. Span 5 web S2 and web N2 elevation view

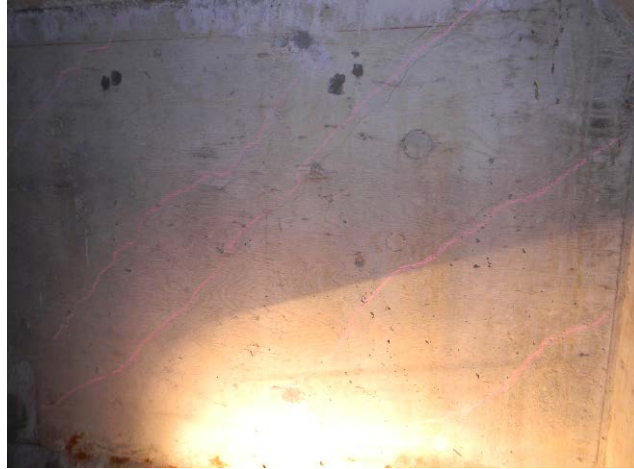
Figure 7.8. Diagonal cracking on interior of box girder

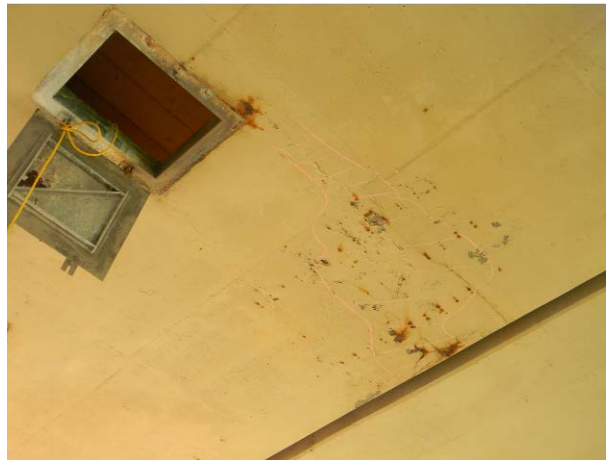
Figure 7.9. Access hatch for structural unit 6N

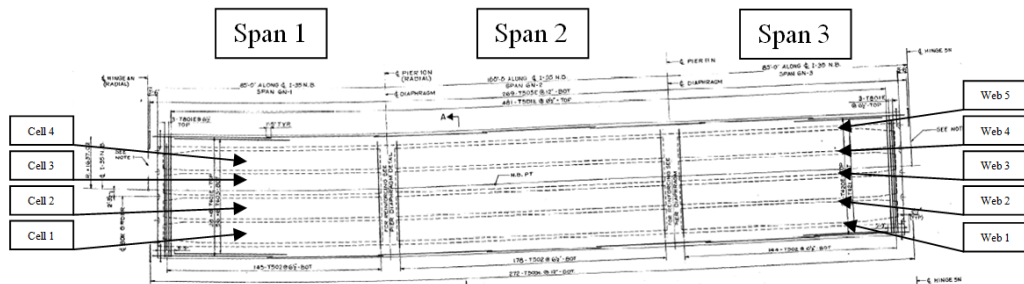
Figure 7.10. Plan view of structural unit 6N

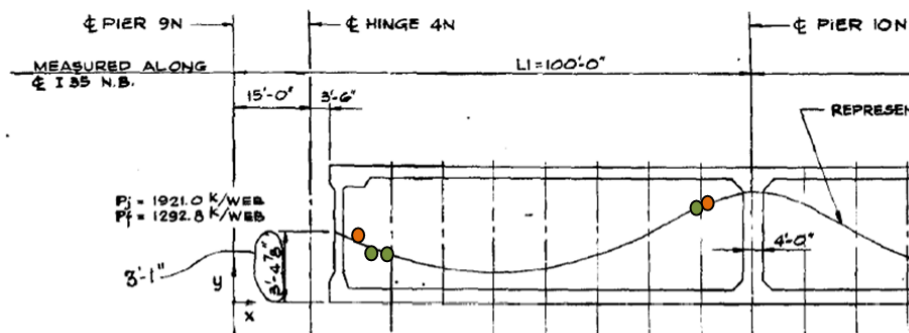
Figure 7.11. Span 1 web 2 structural unit 6N tendon profile view

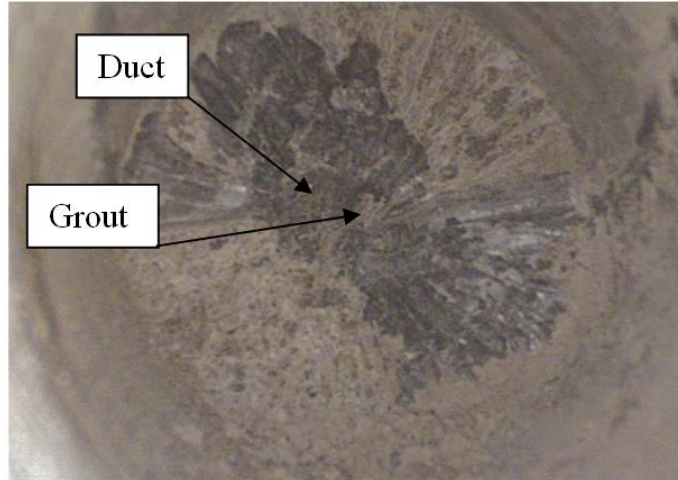
Figure 7.12. Tendon 2 view with borescope

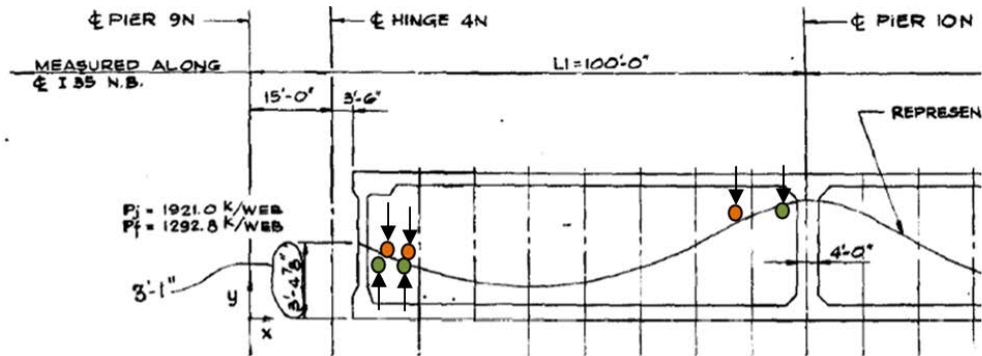
Figure 7.13. Span 1 web 3 structural unit 6N tendon profile view

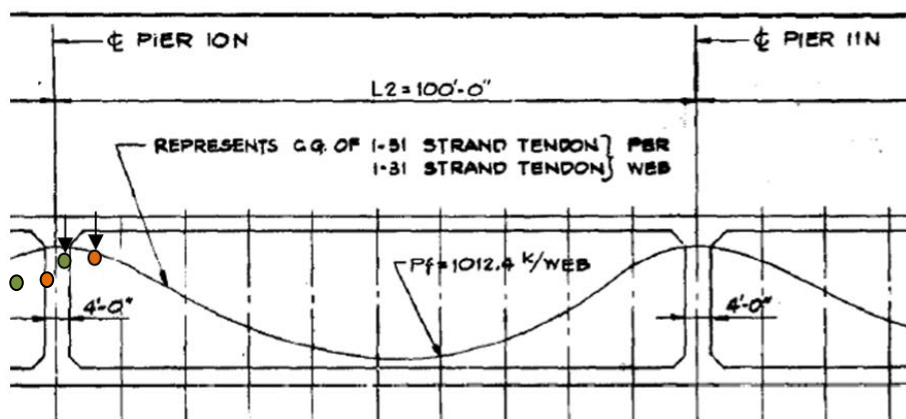
Figure 7.16. Span 2 web 4 structural unit 6N tendon profile view

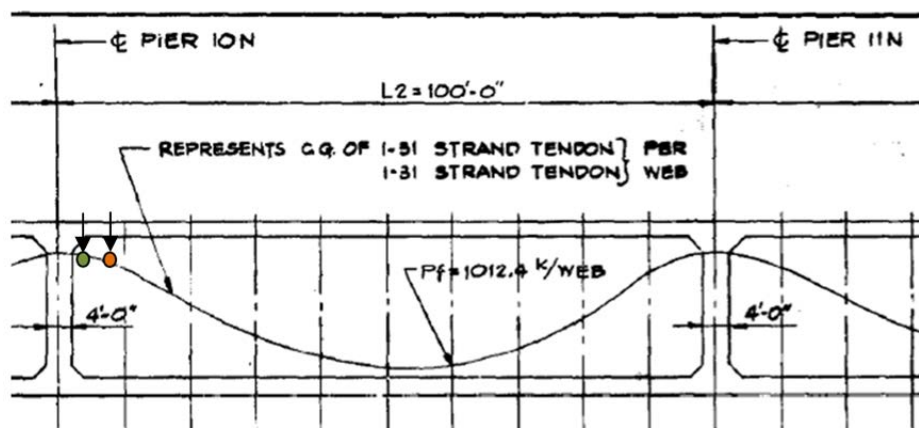
Figure 7.17. Span 2 web 5 structural unit 6N tendon profile view

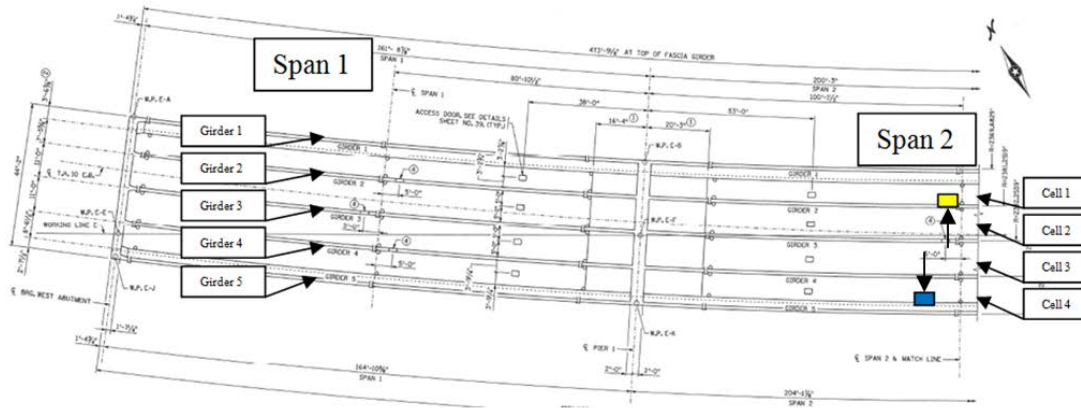
Figure 8.1. Plan view of span 1 and 2

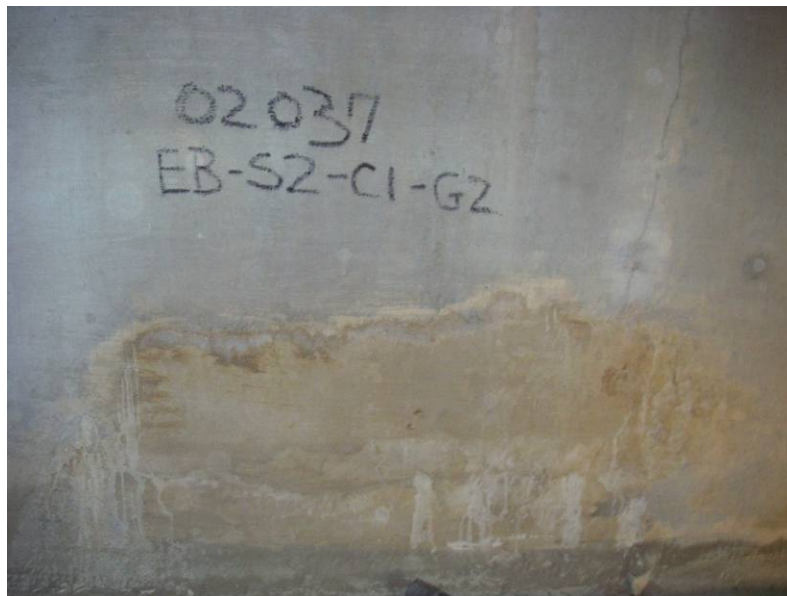
Figure 8.2. Discolored patchwork at mid span (Span 2)

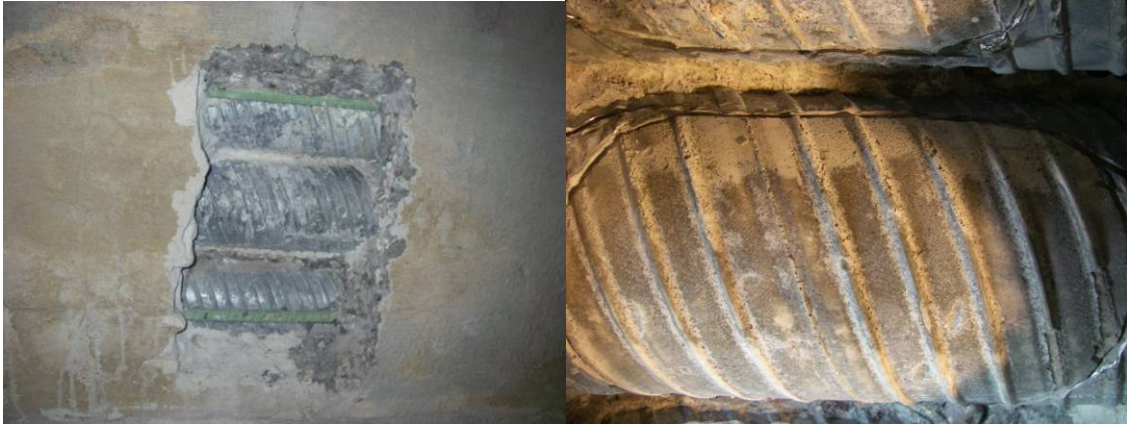
Figure 8.3. (Left) Cut out area exposing ducts

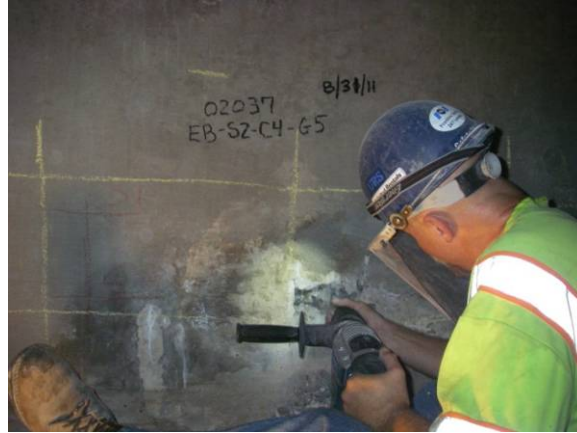
Figure 8.5. Removing cover at inspection area

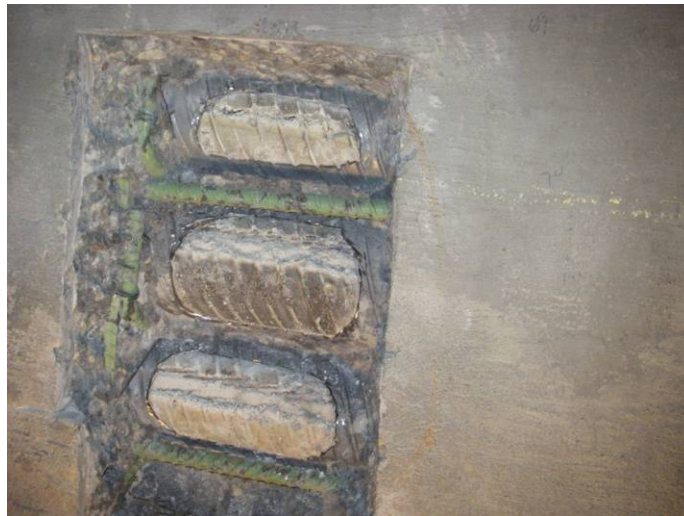
Figure 8.6. Exposed ducts in girder 5 of span 2

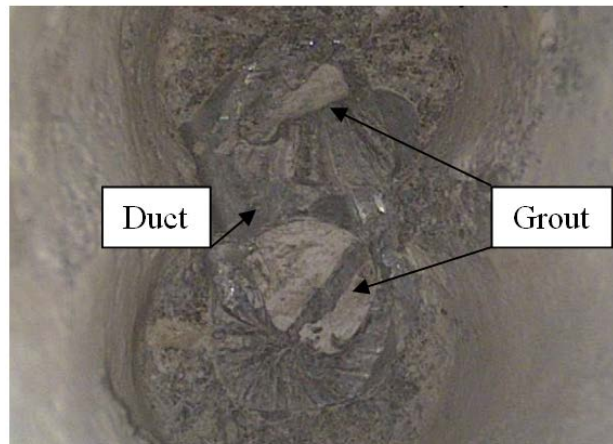
Figure 8.9. Boreoscope picture of drilled hole in girder 5 of span 2

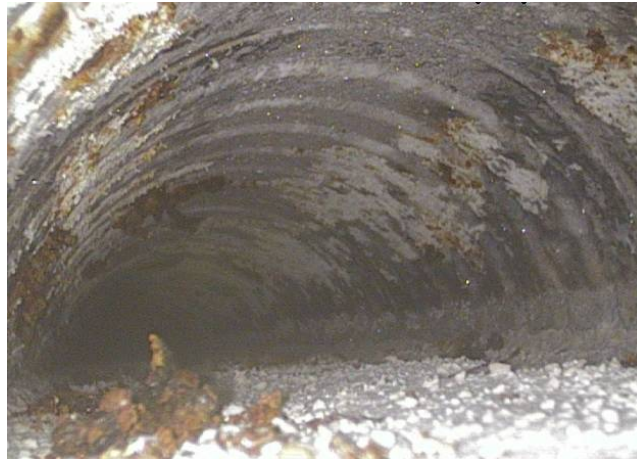
Figure 8.10. Bore scope picture looking toward highpoint in tendon 1
