Development of Best Practices for Inspection of PT Bridges in Minnesota

Minnesota
Department of
Transportation

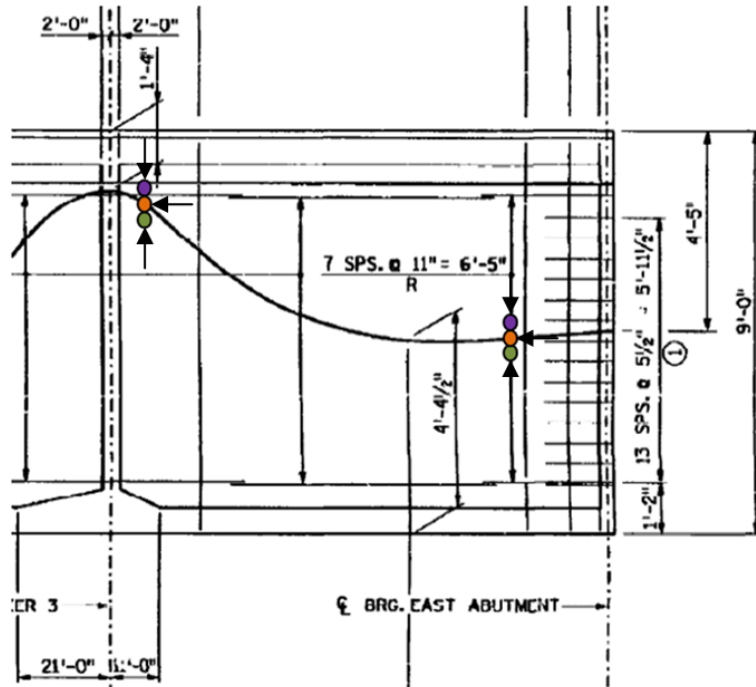
Figure 8.18. Span 4 tendon profile of girder 4

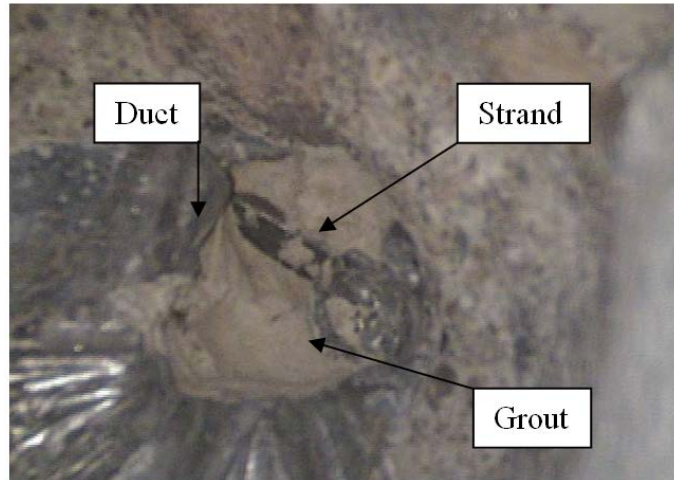
Figure 8.19. Borescope picture of drilled hole in girder 4 of span 4

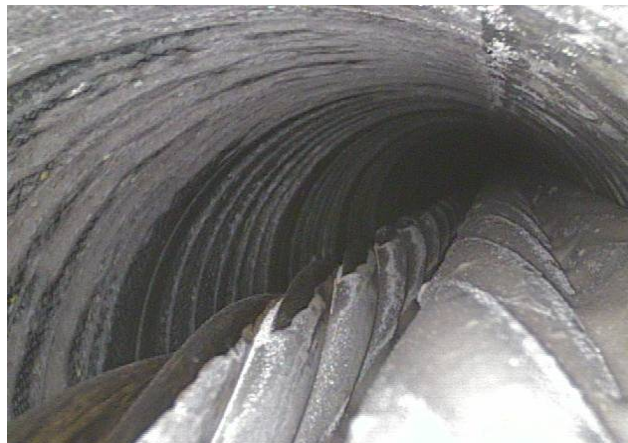
Figure 8.20. Borescope picture looking toward highpoint in tendon 3, 6 inches (15.2 centimeters) inside of the inspection hole

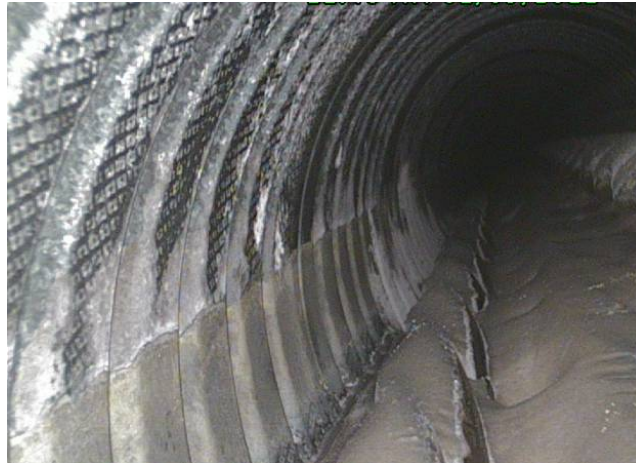
Figure 8.21. Boreoscope picture looking toward highpoint in tendon 3, 24 inches (61 centimeters) inside of the inspection hole

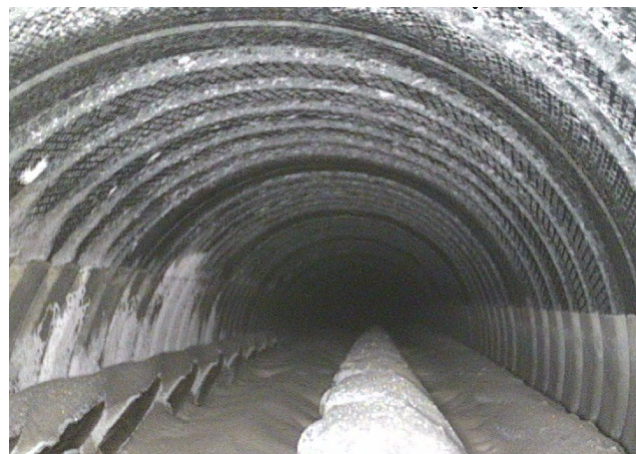
Figure 8.22. Boreoscope picture looking toward highpoint in tendon 3, 3.5 feet (1.07 meters) inside of the inspection hole

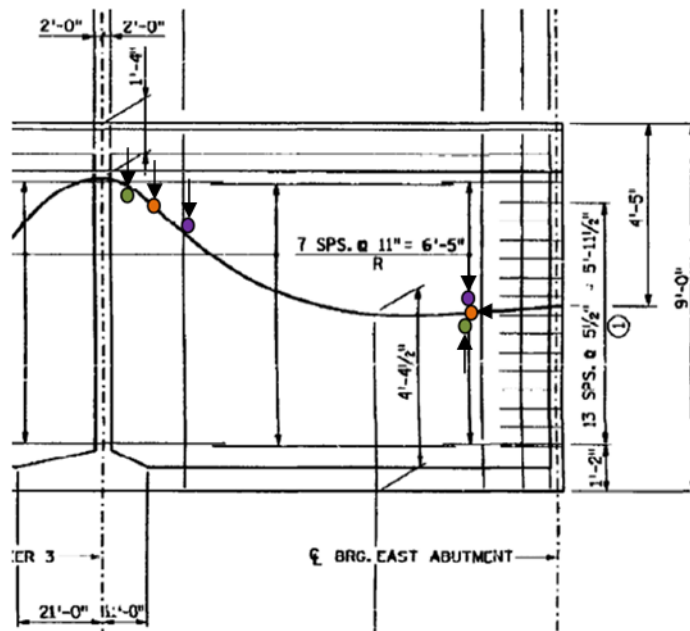
Figure 8.24. Span 4 tendon profile of girder 5

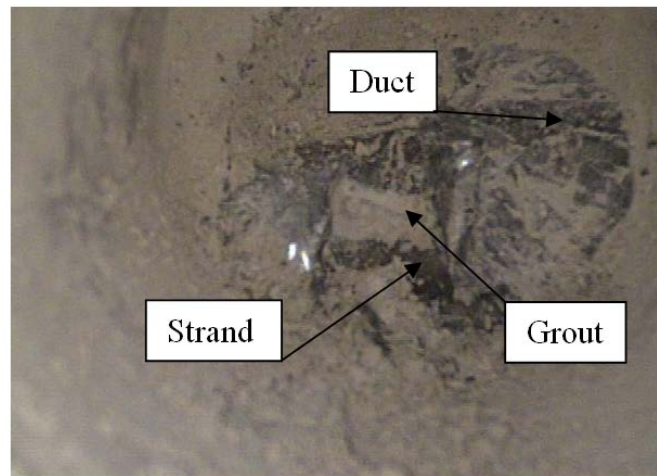
Figure 8.25. Borescope picture of drilled hole in girder 5 of span 4

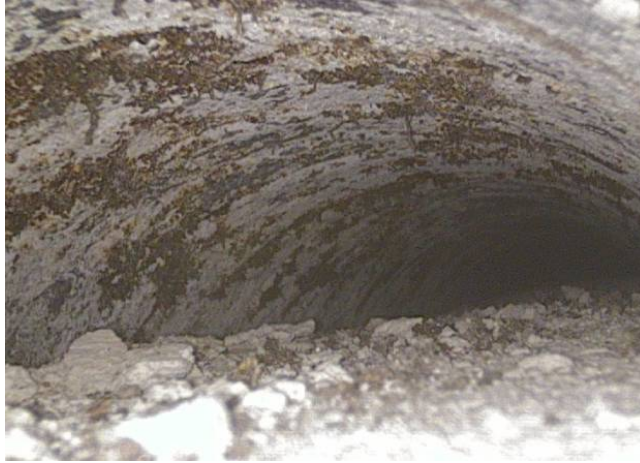
Figure 8.26. Borescope picture looking toward highpoint in tendon 3, 6 inches (15.2 centimeters) inside of the inspection hole

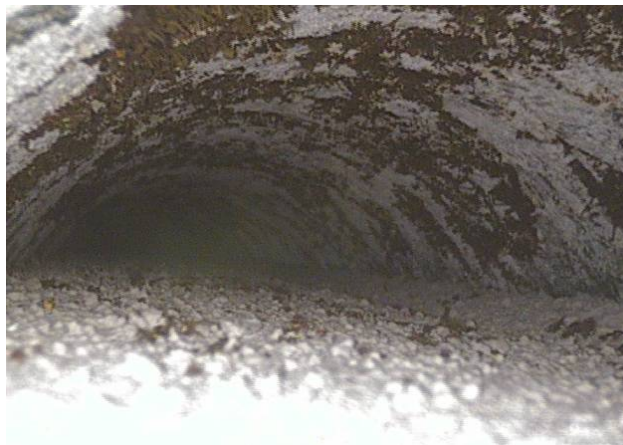
Figure 8.27. Borescope picture looking toward highpoint in tendon 3, 18 inches (45.7 centimeters) inside of the inspection hole

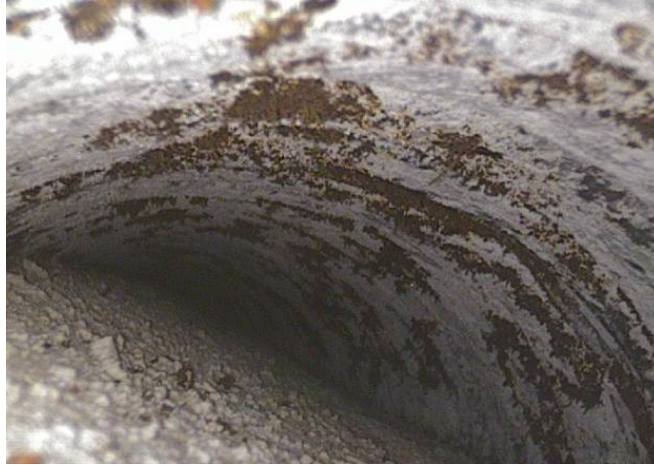
Figure 8.28. Boreoscope picture looking toward highpoint in tendon 3, 5.5 feet (1.68 meters) inside of the inspection hole

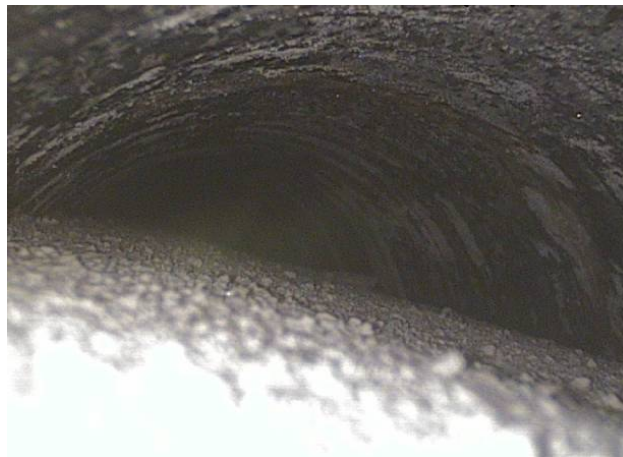
Figure 8.29. Boreoscope picture looking toward low point in tendon 3, 46 inches (116.8 centimeters) inside of the inspection hole

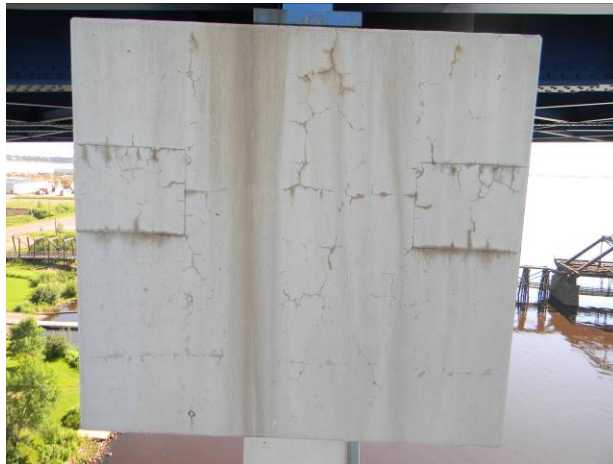
Figure 9.1. PT cap on Blatnick Bridge pier

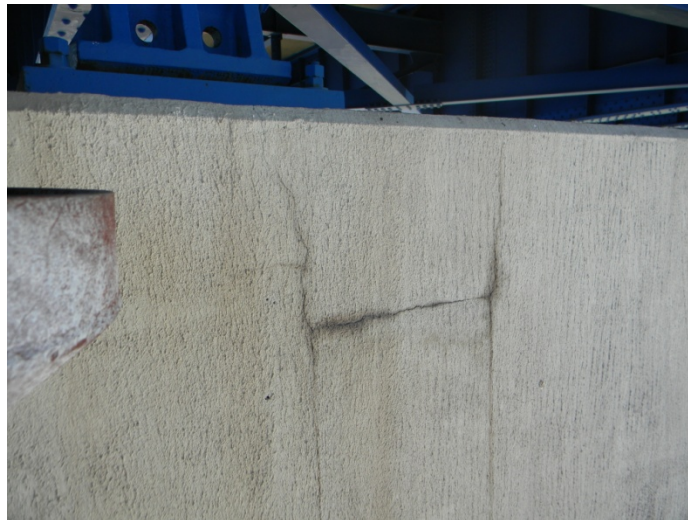
Figure 9.3. Vertical and horizontal cracking in pier

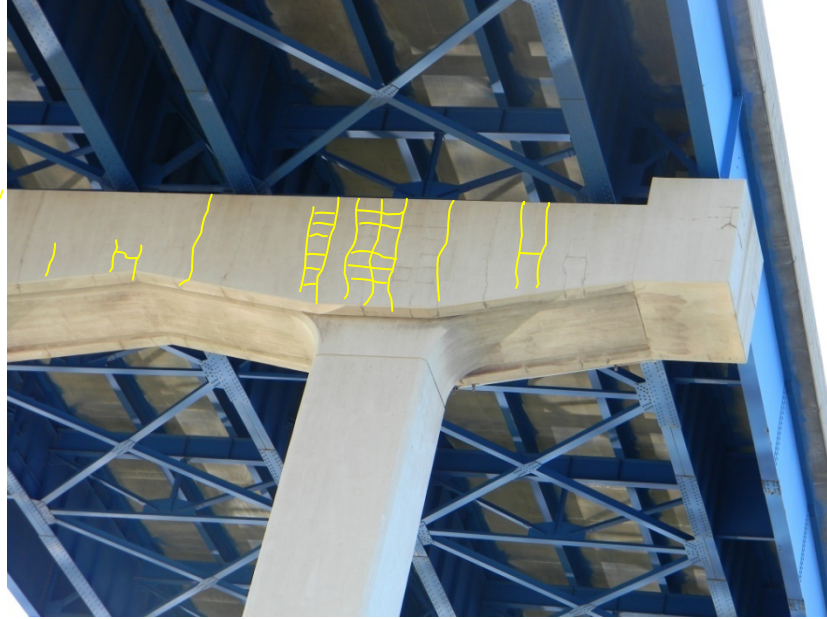
Figure 9.4. Longitudinal view of typical post-tensioned pier

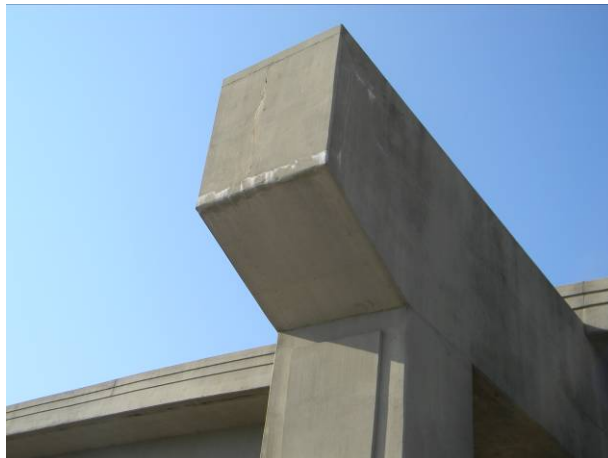
Figure 10.1. Pier with cracking and efflorescence

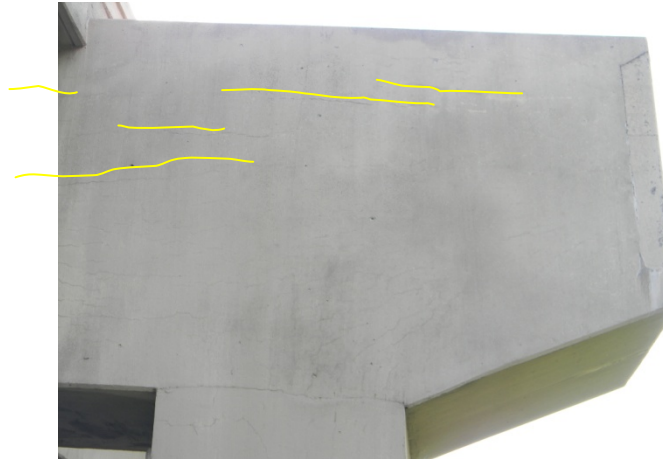
Figure 10.2. Cracking along straddle bent

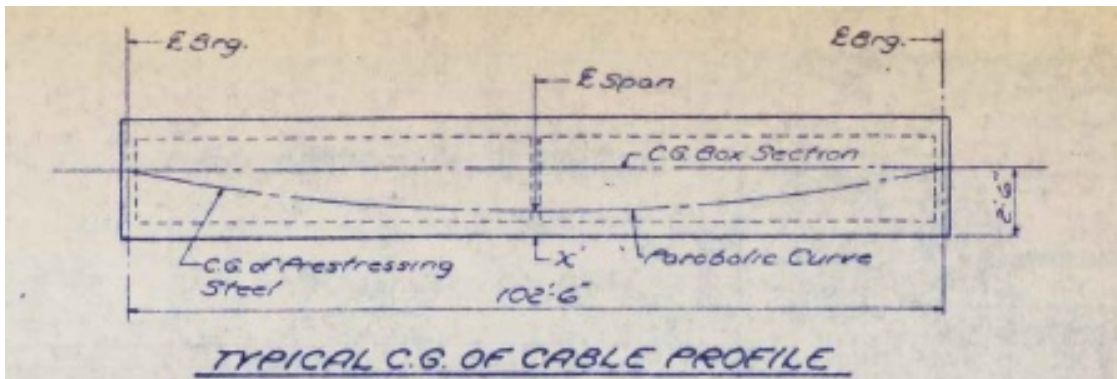
Inspection notes
(focused on PT indicators):
