# TECHNICAL SUMMARY

# Evaluation of Paving Fabrics for Isolation of Bituminous Cracking

*This Technical Summary pertains to the LRRB-produced Report 2008-02, “Evaluation of Paving Fabrics for Isolation of Bituminous Cracking,” published January 2008. The full report can be accessed at <http://www.lrrb.org/PDF/200802.pdf>.*

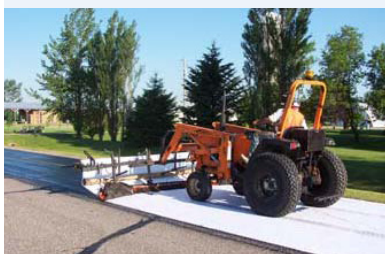
A contractor lays spun-glass paving fabric over asphalt before overlay.

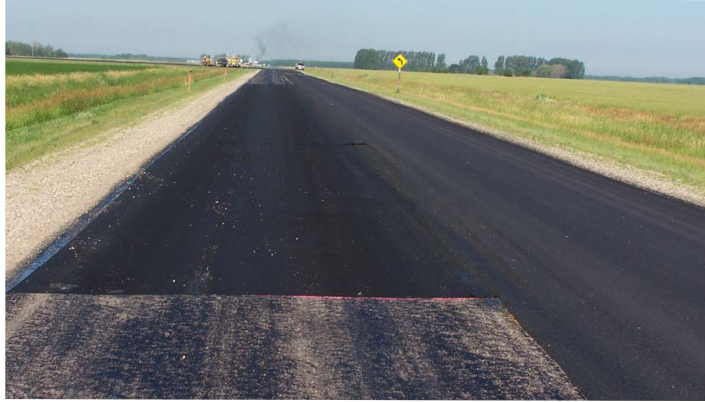
After applying a 0.5-inch blade asphalt leveling course, contractors laid paving fabric and overlaid it as in the left lane shown above. The fabric demonstrated no real benefit over sections without fabric.

According to our evaluation criteria, the fabric performed poorly, countering the claims of pavement fabric vendors. While spun-glass paving fabric can isolate heavy crack sealant from new overlays at less expense than milling and replacing asphalt with sealant, the use of paving fabric between asphalt layers added no structural strength and failed to retard early thermal and centerline cracking. Fabric sections and control sections with no fabric performed equally in terms of distress cracking. This cracking did not reflect through overlays in the first two years following installation. Investigators concurrently examined the impact of subjecting pavement sections to a 0.5-inch leveling course before overlay instead of milling them. They found that this practice also mitigates heavy crack sealant effects on main courses.
