Use of Crushed Concrete Products in Minnesota Pavement Foundations

| 4. Title and Subtitle USE OF CRUSHED CONCRETE PRODUCTS IN MINNESOTA PAVEMENT FOUNDATIONS | | 5. Report Date March 1995 | |
| 7. Author(s) Mark B. Snyder, Ph.D., P.E. | | 8. Performing Organization Report No. | |
| 12. Sponsoring Organization Name and Address Minnesota Department of Transportation 395 John Ireland Boulevard Mail Stop 330 St. Paul Minnesota, 55155 | | 13. Type of Report and Period Covered Final Report 1987-1994 | |

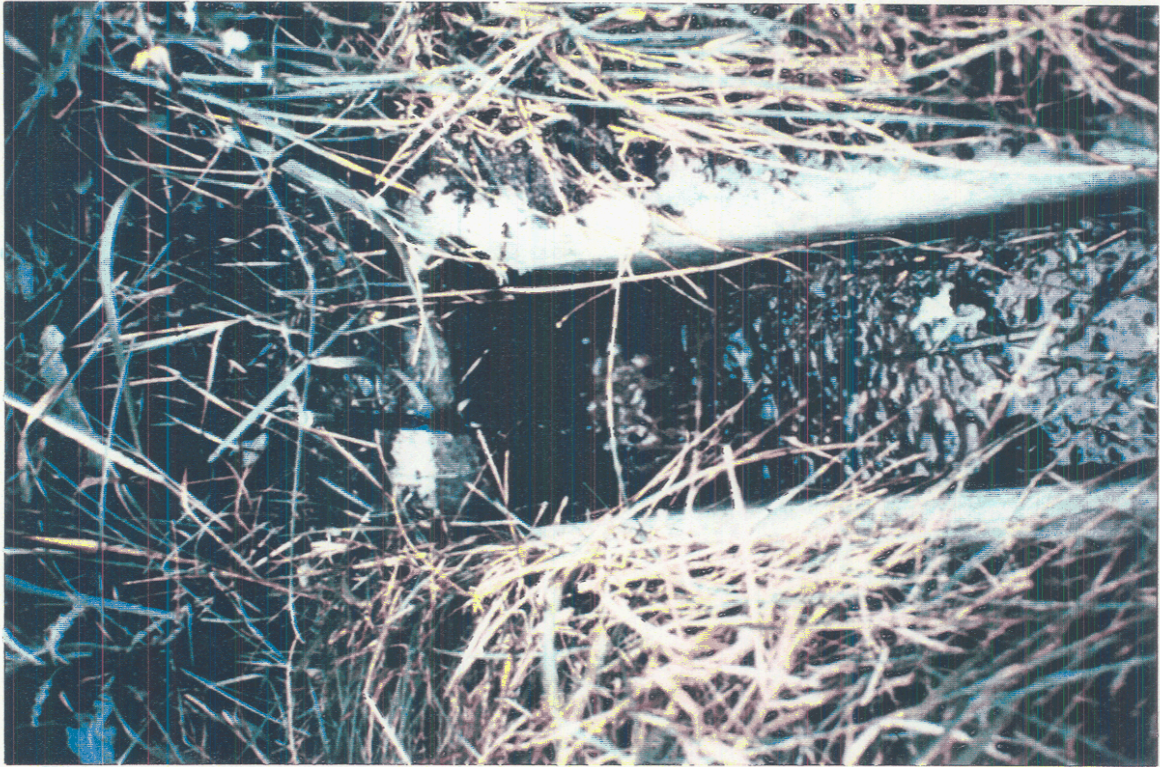
A section of I-90 near Austin, Minnesota was reconstructed in 1985 using recycled concrete base materials. Site visits conducted as early as 1987 revealed that while some of the drain pipes had remained clean, others were approximately 1/4 filled with material deposits (Figures 1 and 2). More recent site visits by this author (summer of 1994) found minor material deposits in some drain pipes, with more significant deposits in and around the concrete drain pipe head walls (see Figures 3 and 4). Interviews with Mn/DOT personnel indicate that the drains have been maintained (cleaned) periodically since construction. All of the drains observed now appear to be carrying water and are not significantly obstructed at the outlets. Areas of vegetation kill were observed near some drain outlets and some metal rodent guards were corroded (see Figures 5 and 6). However, frogs and water insects were observed living in the water that was pooled in and around the drain outlet headwalls, suggesting that current effluent is not toxic.

Figure 1. Photo of typical I-90 (Austin, MN) drain outlet, 1987.

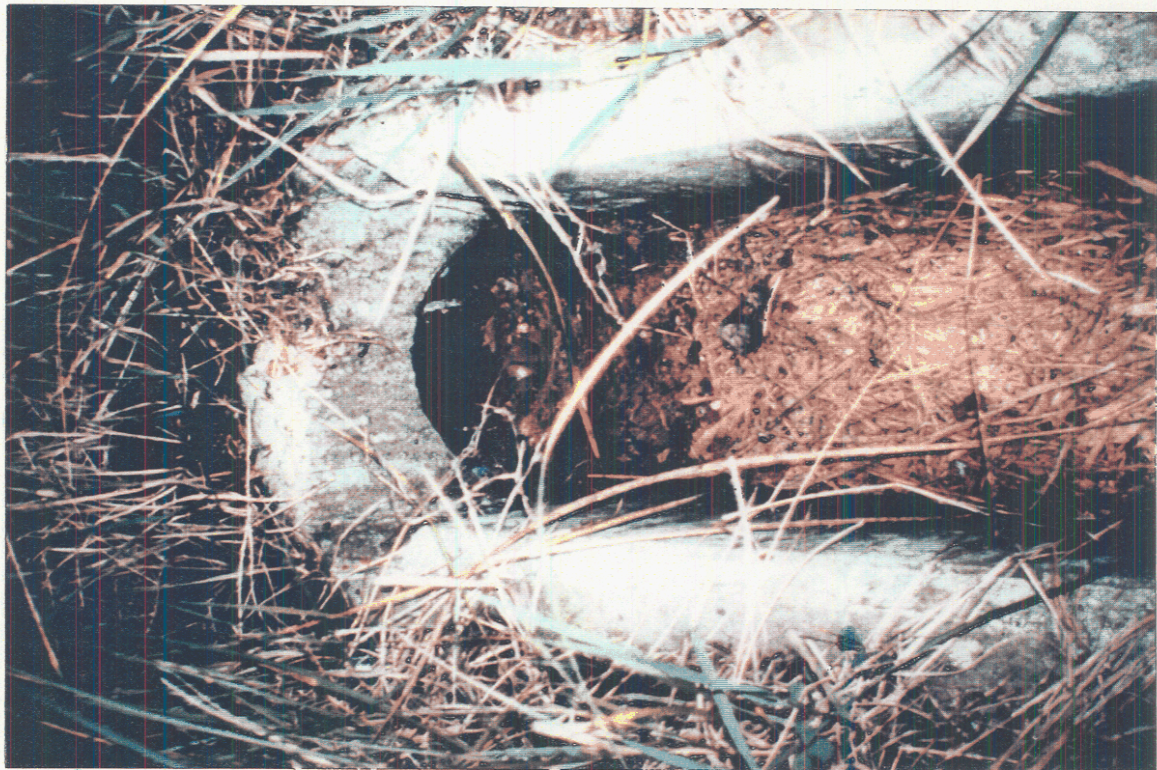
Figure 3. Photo of typical I-90 (Austin, MN) drain outlet, 1994.

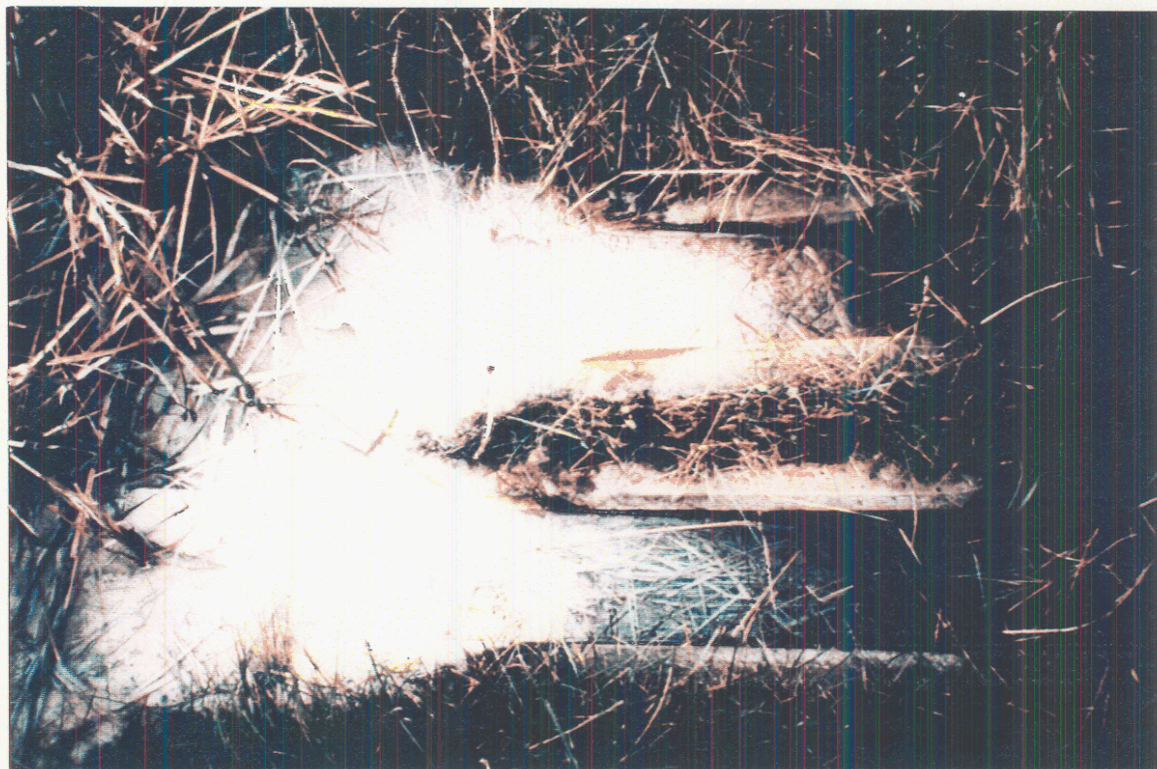
Figure 4. Precipitate around I-90 (Austin, MN) drain headwall.

The use of mild acidic backwash has been suggested as a means of dissolving or loosening calcium carbonate precipitate buildups in pavement drain systems. The cost-effectiveness and potential environmental impact of this approach should be studied before adoption. This author believes that the use of open-graded recycled concrete drainage layers along with unwrapped pipes placed with adequate slope should eliminate the formation of most precipitate in drainage pipes and would, therefore, also eliminate the need for an acidic backwash.

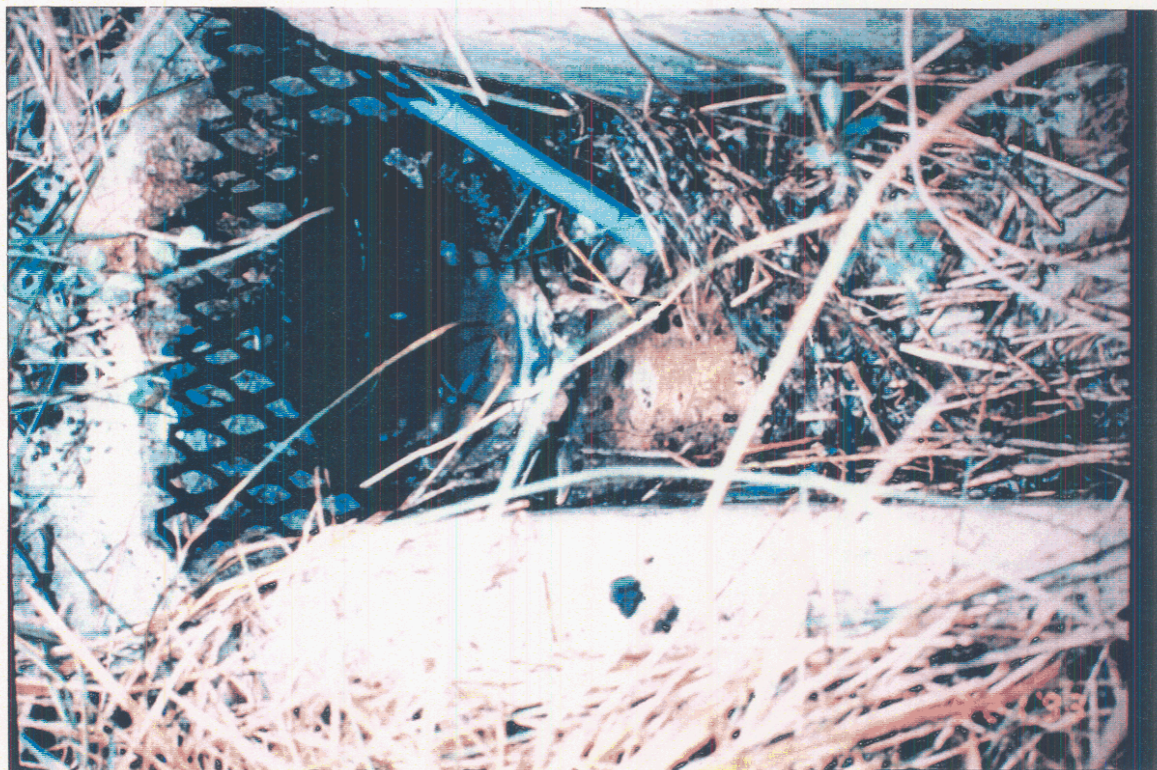
Figure 6. Rodent guard corrosion on I-90 (Austin, MN), 1994.

Concerns about the corrosion of rodent guards would be eliminated if Mn/DOT were to require the use of rodent guards fabricated from plastic or other corrosion-resistant materials. In addition, the recommendations made concerning the reduction of precipitate/drainage problems would also probably reduce corrosion problems.
