Pavement Rehabilitation Selection Making a Decision: Applying What You've Learned

LRRB Pavement Rehabilitation Selection

Rehabilitation Selection

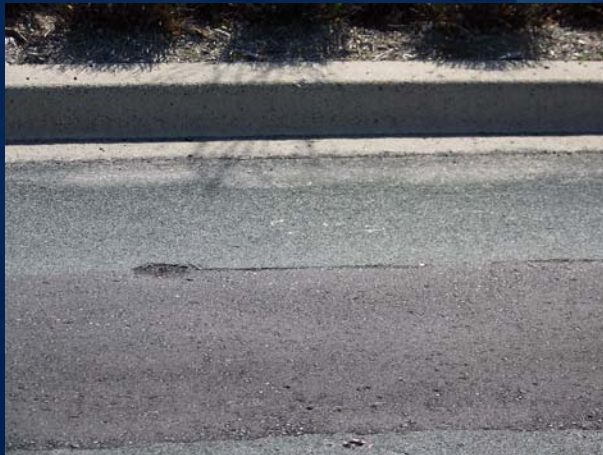
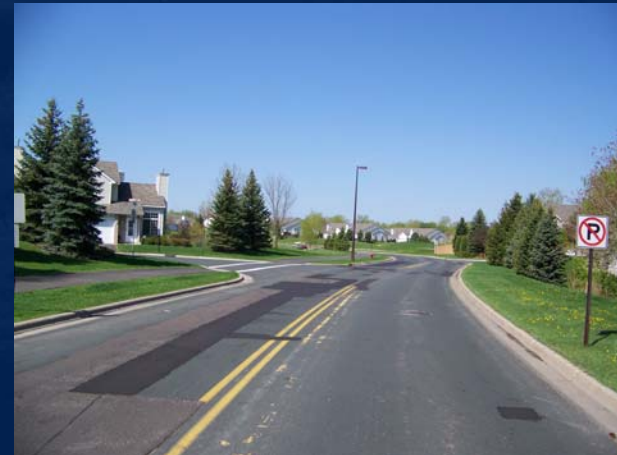
Pavement Condition

- The wearing course began debonding from the lower layers in the spring of 2008
 - A number of shallow potholes formed
- Potholes were milled and patched

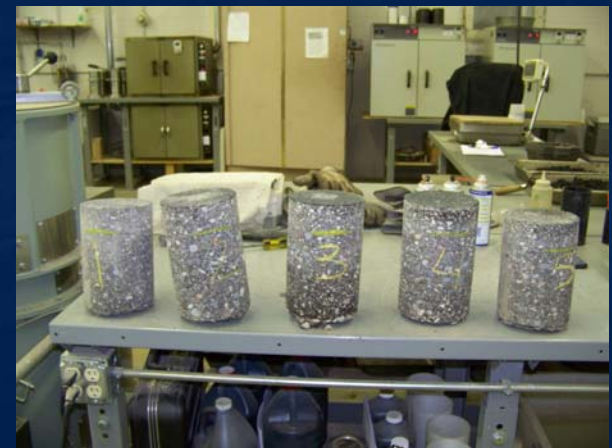
Pavement Strength Evaluation

- In-place and Rice Specific Gravity tests were performed on the bituminous wearing course
- Core densities ranged from 86% to 92%
- Extracted bituminous content was 6.0% in the good areas and 5.7% in the bad areas

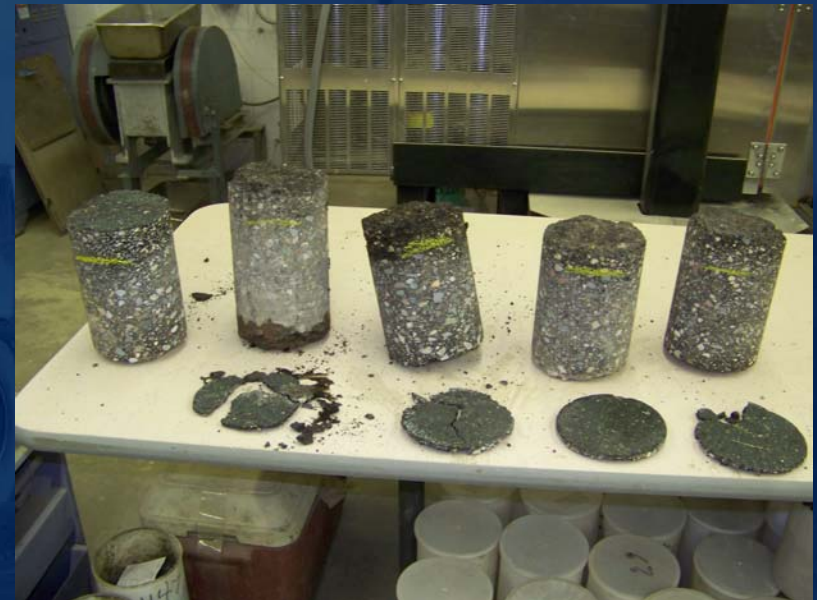
Surface, Base and Subgrade Analysis

- The chip seal has debonded from the underlying wearing course in areas showing surface distress
- There is stripping in the wearing course, causing the shallow potholes

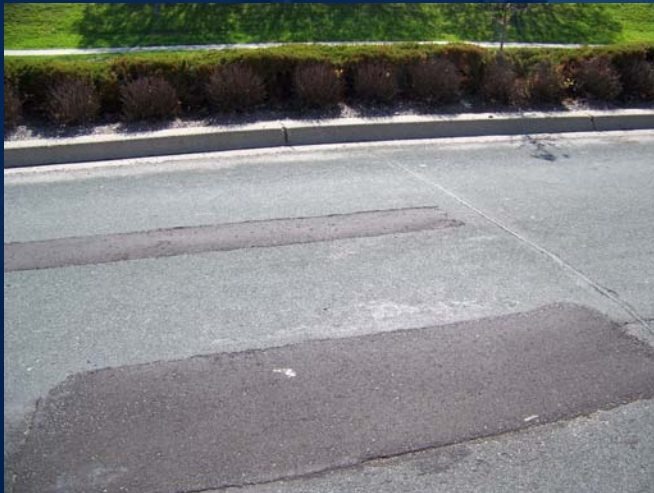
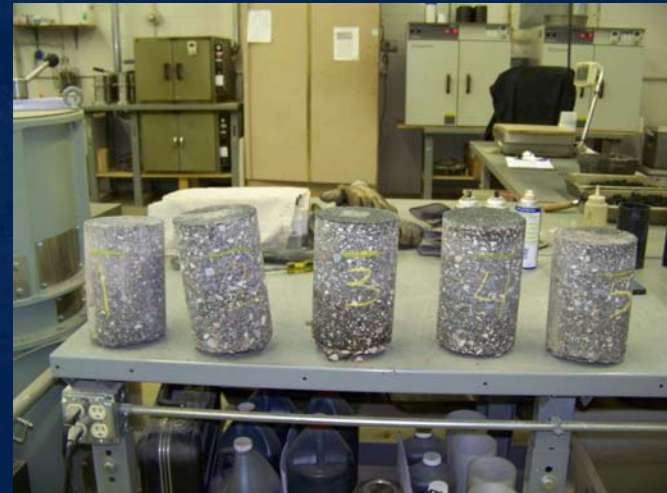
Case Study #1 Overview Surface and Subsurface Drainage Review

- Curb and gutter is currently in place on both roadways and in good working condition
- There is evidence of moisture intrusion into the wearing course underlying the chip seal
 - Seen in the upper 1/2" of cores 3, 4 and 5

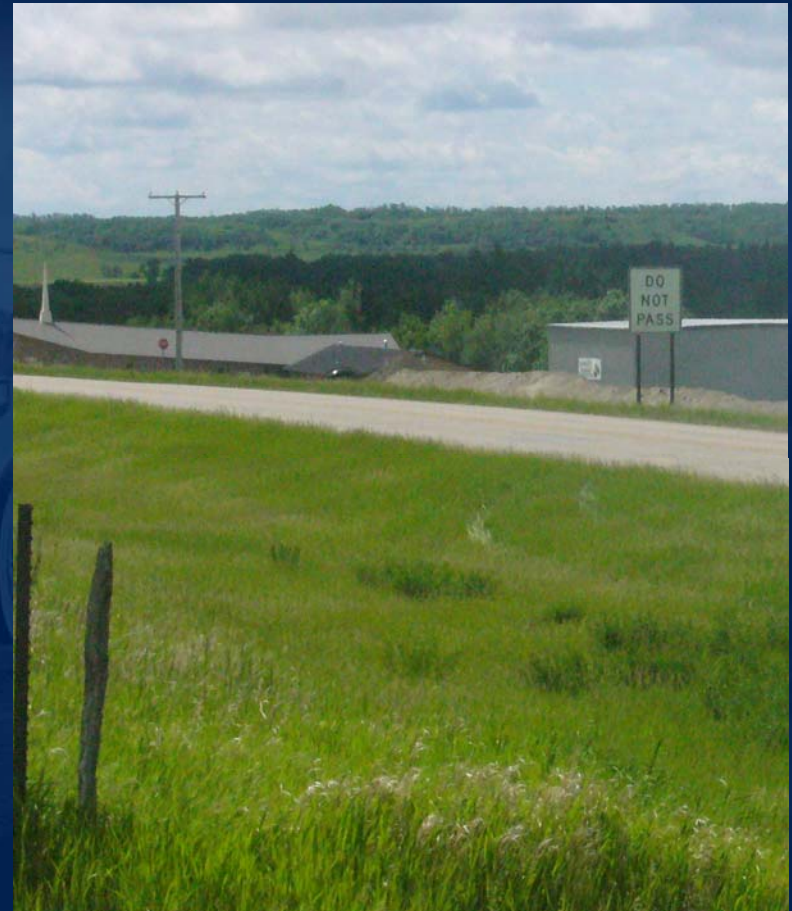
Case Study #2 Overview Surface and Subsurface Drainage Review

- Ditches are in-place
- Roadway appears to be draining adequately

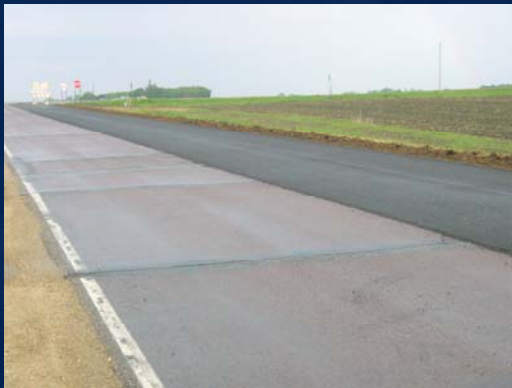
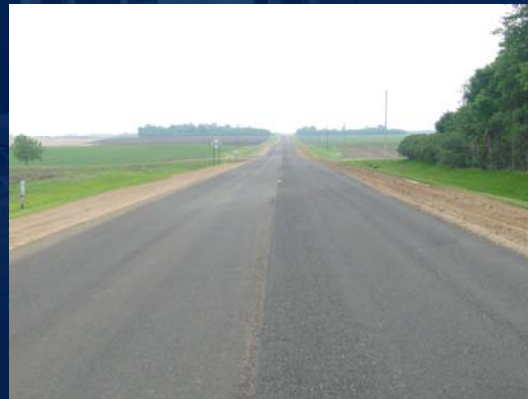
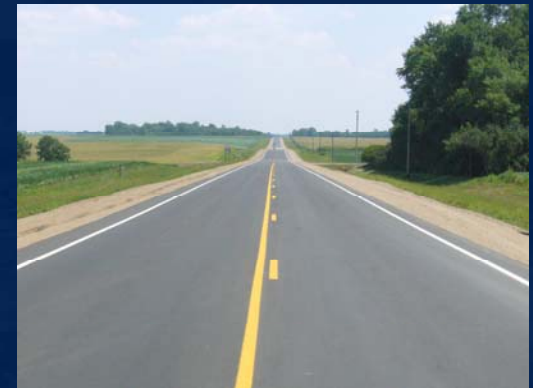
Case Study #2 Recommendations

- Engineered Cold In-place Recycling
 - Recycle 4” of the original bituminous pavement
 - Surface with 3” of bituminous pavement
 - Drain tile

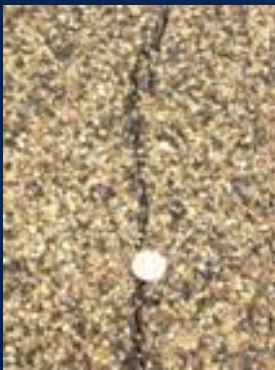
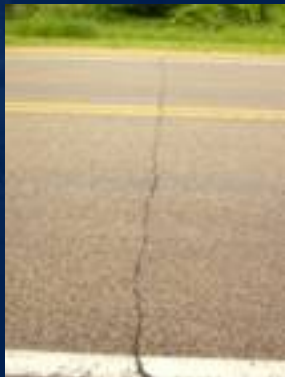
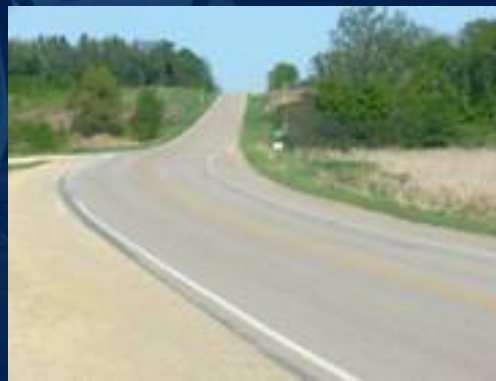
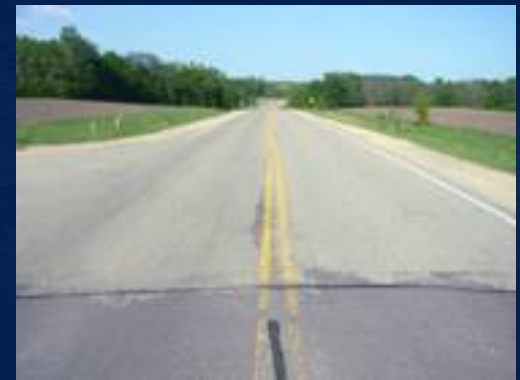
Case Study #2 Comparisons

- Different approaches taken by the two counties with this roadway:
 - County #1 chose CIR option in 2004
 - 8 low severity transverse cracks within first 8/10th of a mile (2008)

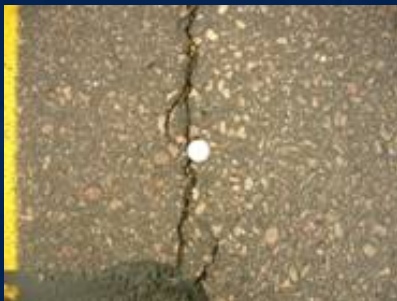
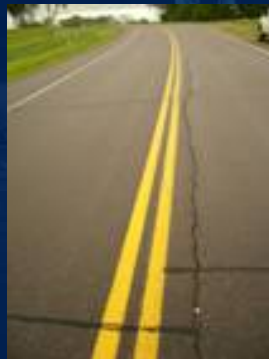
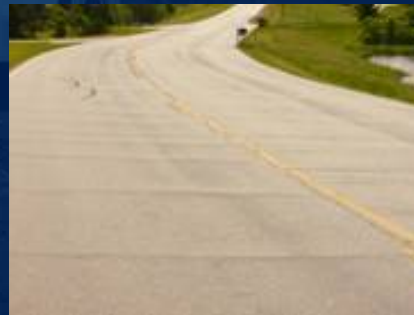
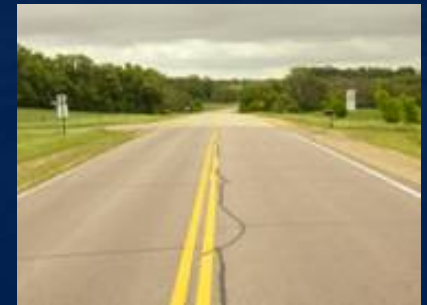
Case Study #2 Comparisons

- County #2 chose 2” Mill and Overlay option in 2005 with Seal Coat in 2006
 - Over 300 low to moderate transverse cracks and numerous longitudinal and fatigue cracks within first 8/10th of a mile (2008)

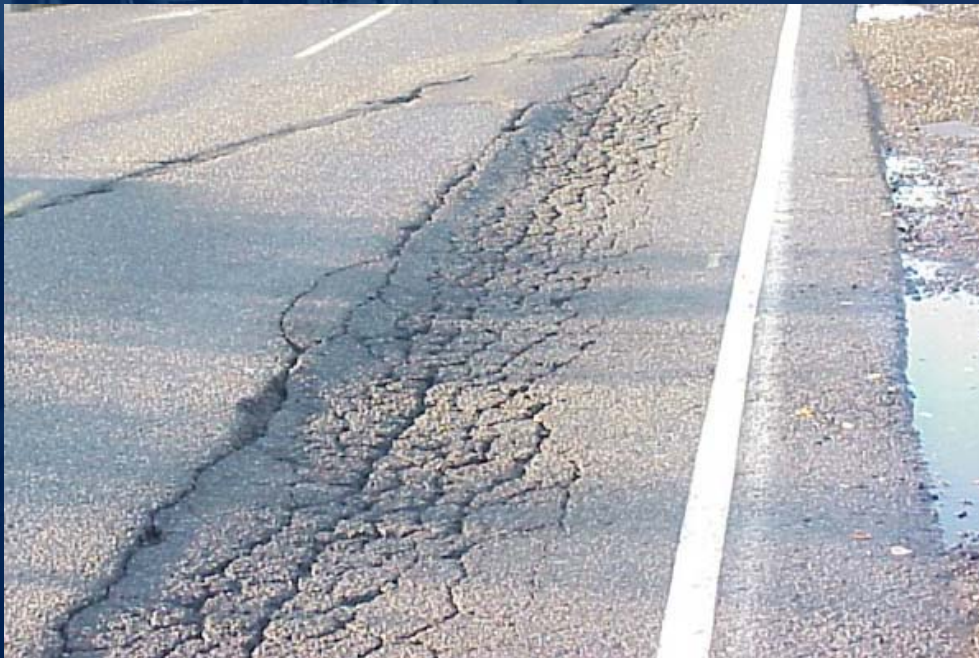
Case Study #3 Overview Pavement Condition

- Severe pavement deterioration
 - Rutting $>1.5''$ deep

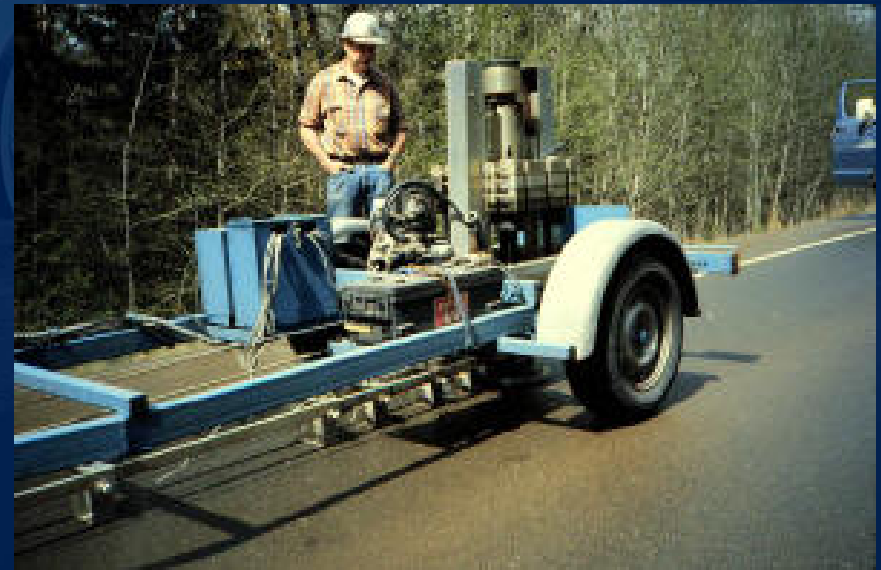
Surface, Base and Subgrade Analysis

- Preliminary deflection testing indicated the in-place subgrade to be very wet and unstable

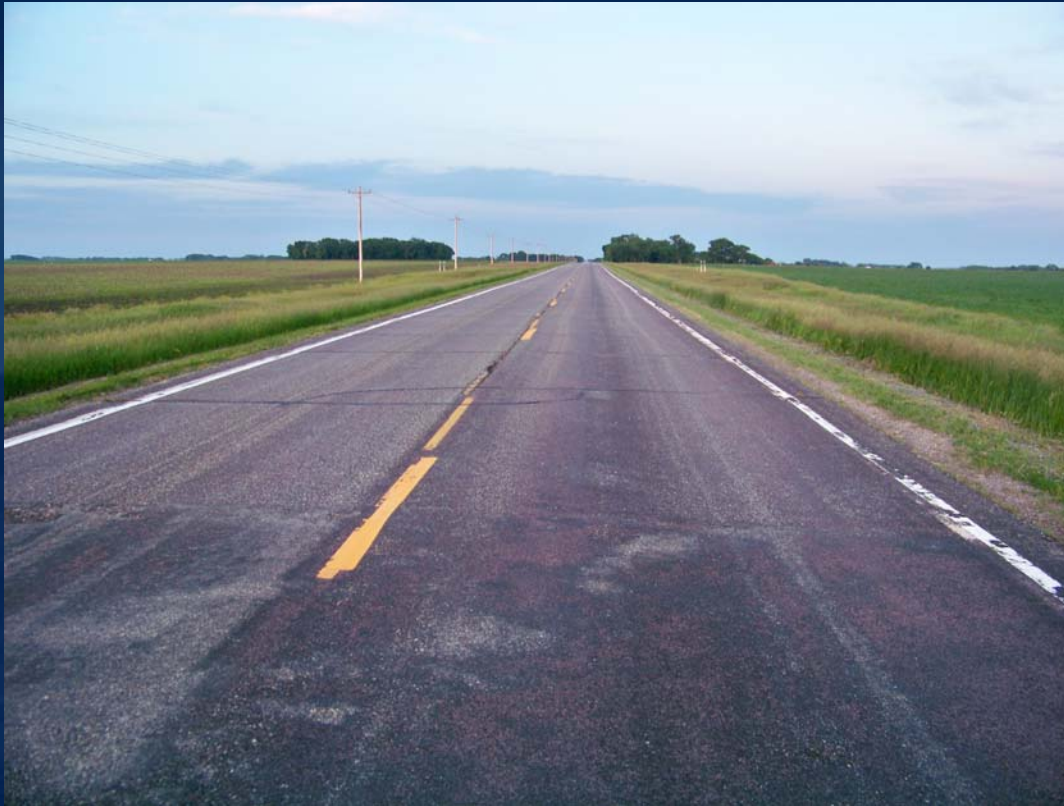
- 3" Bituminous Overlay
 - Crack spacing is 15 – 20'

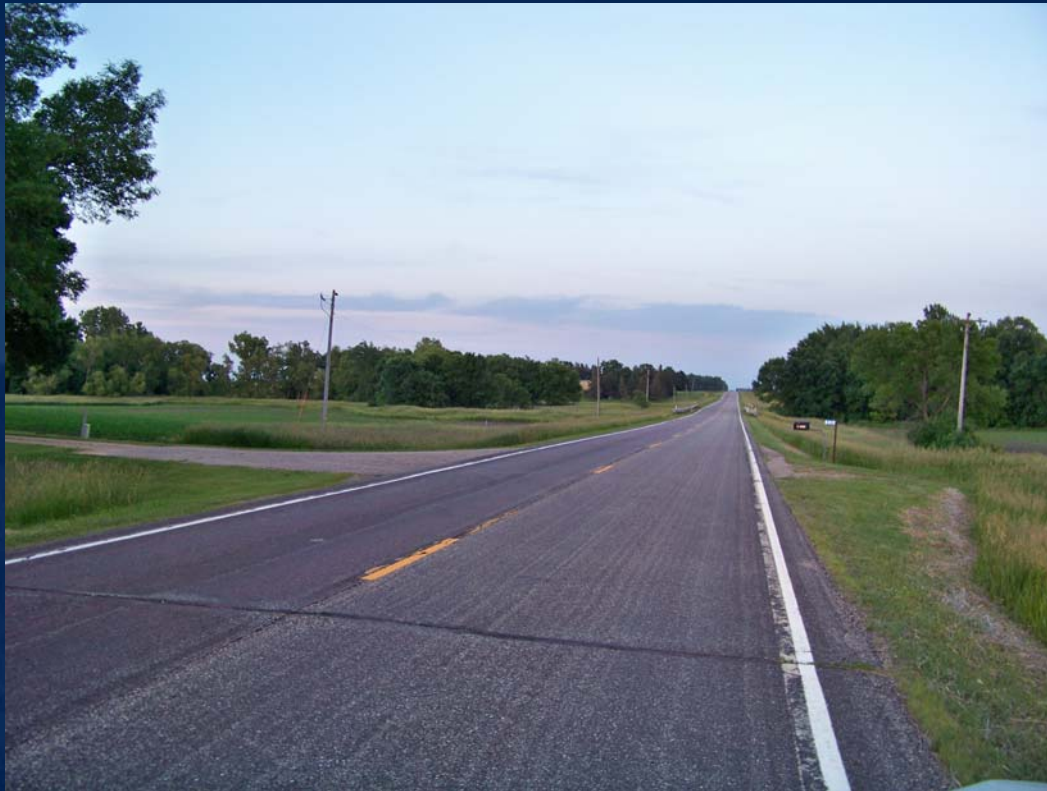
- 5" Bituminous Overlay
 - Crack spacing is 50'

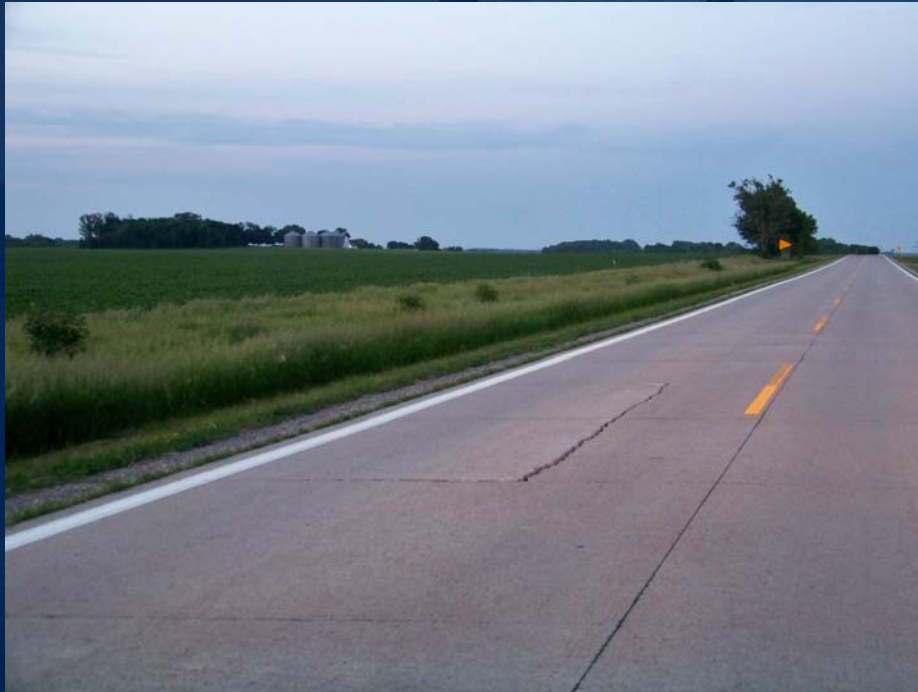
- 6" Whitetopping
 - Bituminous surface was milled before placement
 - Bonded
 - Undoweled
- Only required maintenance has been patching over settled culverts
- Some longitudinal cracking

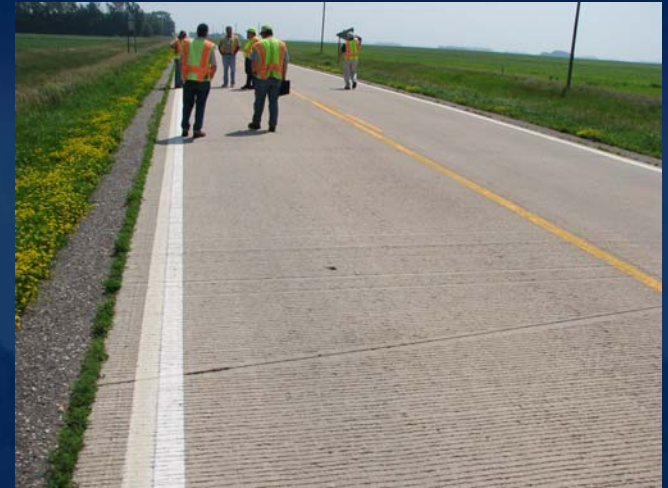
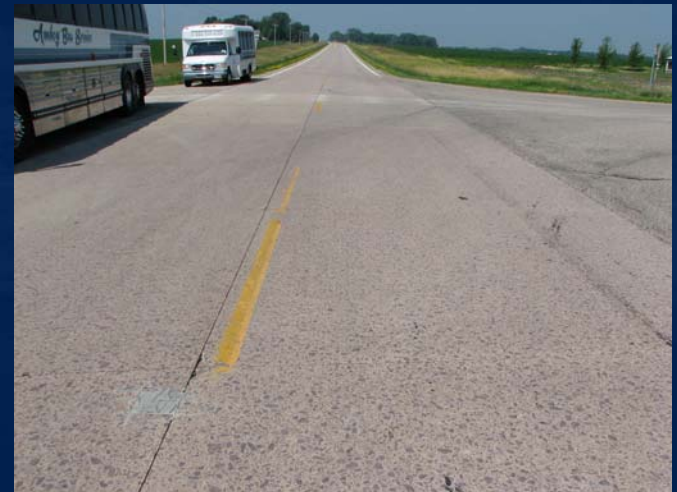
Case Study #3 Recommendations

- Proposed Design:
 - 6" Whitetopping
 - Milled bituminous surface for uniform thickness
 - Bonded
 - Undoweled
 - Edge drains along the roadway
 - Will reduce subgrade instability and extend the life of the pavement

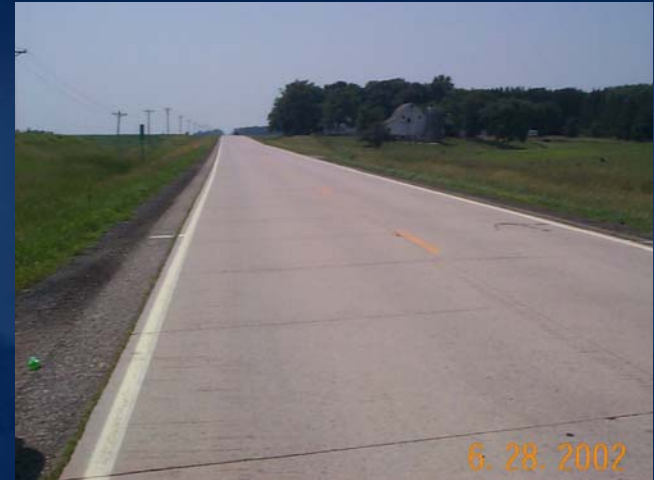
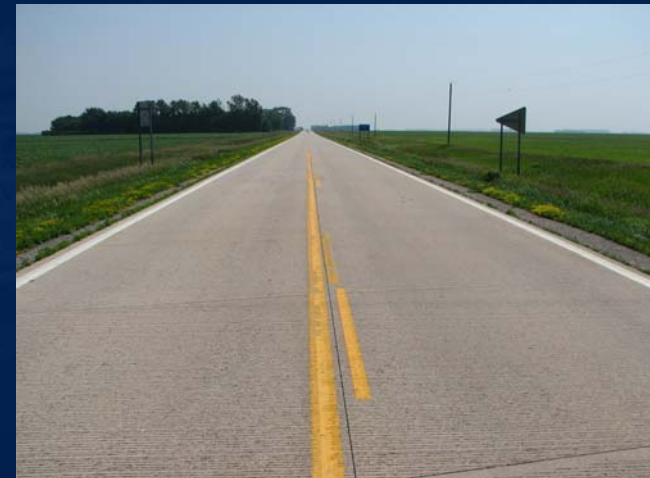
Case Study #3 Recommendations

- Although all sections are in good condition (2002), this proposed design:
 - Is the most economical design to date
 - Has required no maintenance to date
 - Has a better ride quality than the other sections
