Section 4: Inventory Methodology and Findings

Section 4.1: Purpose and Summary of the Inventory Effort

City of Rancho Cordova ADA Transition Plan

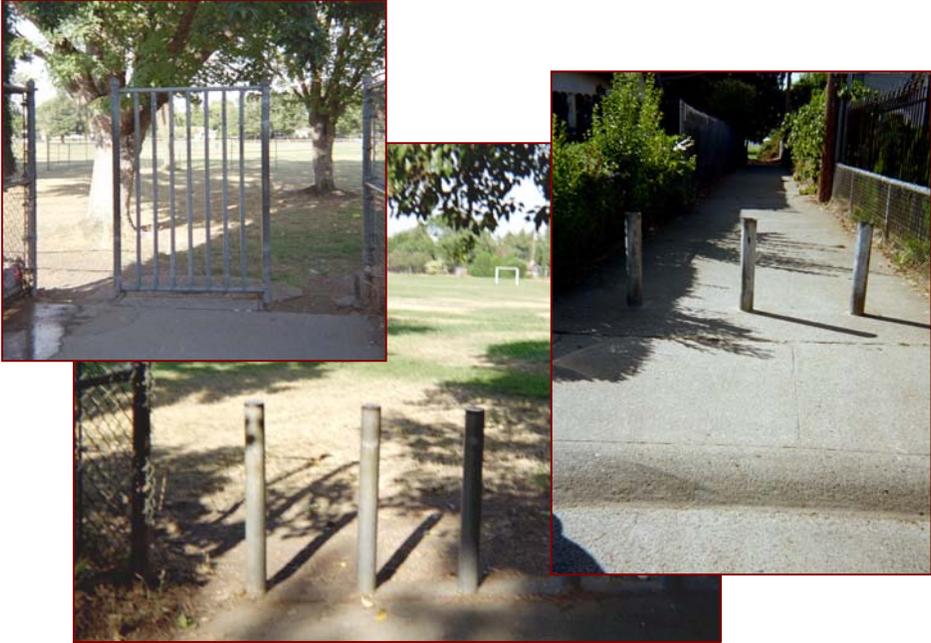
Figure 1: Walkway Examples

- Approximately three walkways leading to schools or park are not ADA compliant (Figure 1).

Moraine Court Walkway adjacent to Cordova Gardens School (left)
Van Nuys Way Walkway adjacent to Riverview School (center)
Atwood Drive Walkway at Ahlstron Park (right)

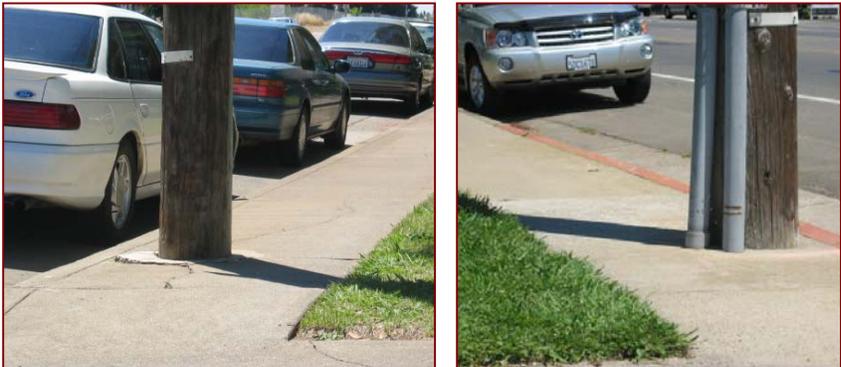
Figure 3: Utility Pole Obstruction Examples - Mather Field Road at the Mather Sports Complex and Senior Center

Obstructions and Obstacles: The general presence and nature of abrupt changes in sidewalk level of greater than one-half inch, paving obstructions or accessibility obstacles immediately adjacent to the corner. The following obstacles near a corner will be recorded: utility pole, traffic light pole, drain inlet, fire hydrant, street furniture and newsstand. (Figure 3)

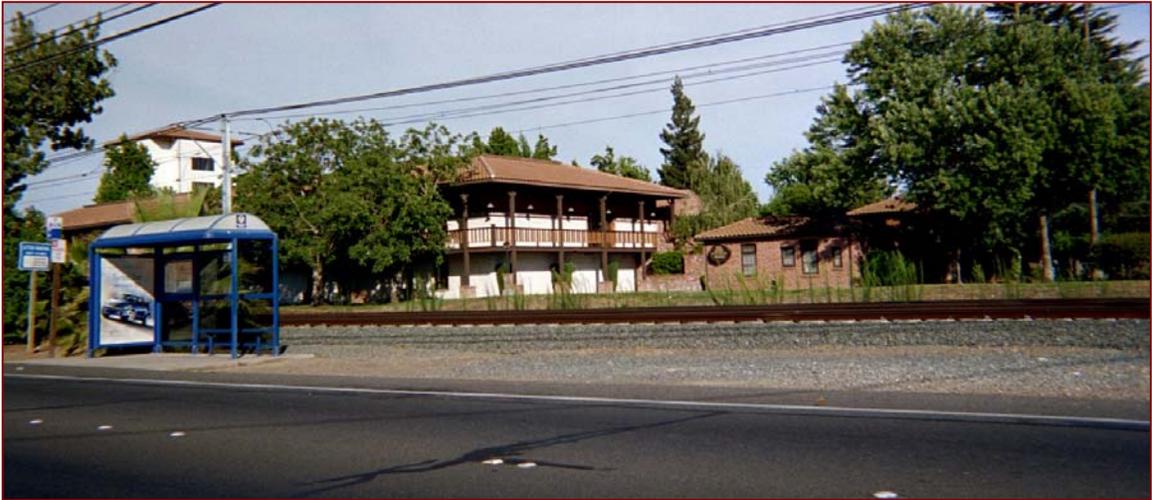
Figure 4: Bus Stop Path-of-Travel Example - Folsom Blvd and Routier Rd

Transit Stop Type: The parameters of the transit stop type are none, light rail, bus and other (Figure 4).
