What Can Be Expected With Multi-Lane Roundabouts?

June 2016 www.LRRB.org Report #2016RIC12

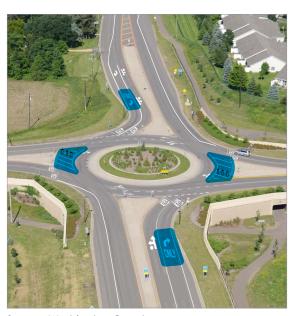
Source: Washington County
Modification indicated by blue highlight

Constructing roundabouts with more lanes than are needed for current traffic levels can create unnecessary opportunities for driver error. Roundabouts can be constructed to accommodate future expansion, yet be configured for current traffic levels to prevent driver error and to reinforce proper driving behaviors. This image shows a roundabout that was originally built to accommodate two through lanes in all directions, but was later modified such that the minor street approaches have only one through lane in the short term, thus reducing driver error and crashes.
